# Breakdown Behaviour of Damaged Low-Voltage Cables: Laboratory Experiments and Field Experience

## Abstract

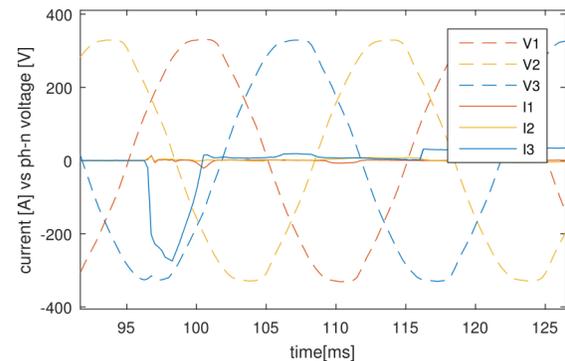
An OIP insulated cable with four 50 mm<sup>2</sup> copper conductors and in addition four 6 mm<sup>2</sup> copper conductors for the public lighting system. The cable has been monitored at the main conductors for 8 months until an outage occurred. An overview of the measurements is shown in Figure 6. During the measurement up to the outage 26 events have been recorded. An example of such event is shown in Figure 7. From the current profiles the 50 Hz base load current is subtracted in order to highlight the transient current. The amplitude is 270 A after compensation for the baseline load with a duration of 4 ms. The arc

Fig. 7 - Triggered event on blue phase recorded at 10-05-2016, with subtracted base load.

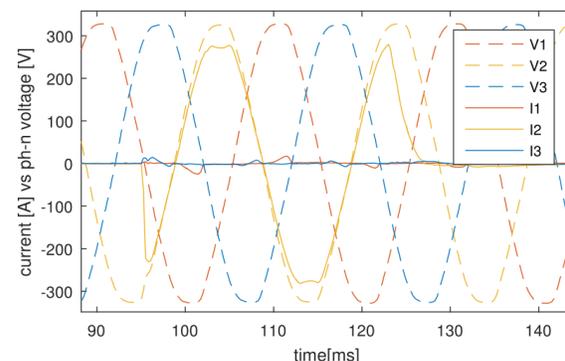
initiated around the peak of the voltage. Over the course of measurement, several events have been recorded with comparable characteristics, mostly for phase 3 (blue), but also for the other two phases. A few days before the outage, a transient with duration of over a power cycle was recorded, Figure 8. Its duration was 30 ms and with amplitude of 270 A on phase 2 (yellow). The fault was found in a mass filled branch joint, at 225 m from the substation.

Fig. 8 - Triggered event on yellow phase recorded at 28-08-2016, with subtracted base load (12 days before the outage).

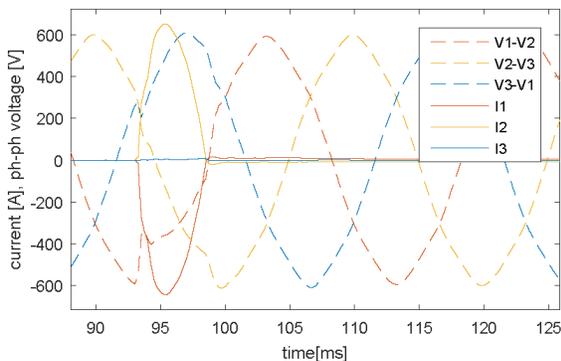
The measured cable has PVC insulation and 50 mm<sup>2</sup> aluminium conductors. The period of measurement was from 14 September till 17 October. An outage had occurred on 18 August, after which an automatic fuse was installed. No events have been triggered by the sensor until 14 October. Afterwards, 12 events have been triggered until an outage occurred at phase 2 later that day (spread over 19 hours). An overview of the last three days is shown in Figure 9. Further events are triggered (16 times, including 5 on which the installed automatic fuse interrupted) for about 9 hours, until the connection was taken out of service by the grid operator. Events are triggered upon transients at the other phases as well. The transient for the first event is shown in Figure 10. This pattern has typical breakdown characteristics with a short circuit between two phases. Most of the later events have similar patterns. All three phases are involved.

Upon investigation, a faulty component was found at 160 m distance from the substation. The actual failing component is not known. Because all three phases are involved, most likely a joint has failed. The automatic fuse recorded short circuit currents up to 2 kA.

**Fig. 10** - Triggered event on red and yellow phase recorded at 14-10-2016 (19 hours before the outage and 45 minutes before the next event).

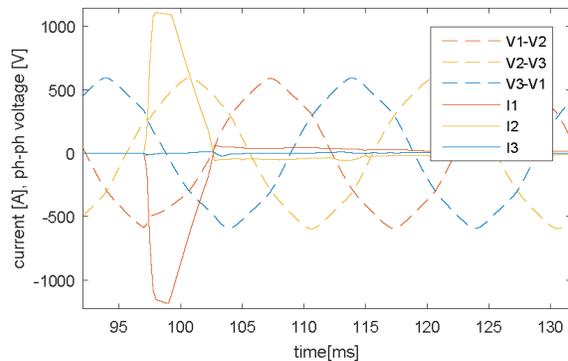
The measurement unit was installed in addition to an automatic fuse. During the measurement time of three weeks, several issues emerged. First, an illegal tap was found. Second, the cable was overloaded at regular time instances: the cable is rated for 160 A, while currents exceeded 250 A for about a minute every evening. This did not cause a fuse break. During the measurement time, one transient with the characteristics of a cable fault was detected. This transient is shown in Figure 11. Several transients with full cycle duration similar as the one shown in Figure 12 occurred. The pattern does not match typical characteristics expected from a breakdown, as the current starts near the voltage zero crossing. This is expected to be a switching transient.

**Fig. 11** - Triggered event for case study 3 on red and yellow phase recorded at 18-11-2016 with subtracted base load. Clipping occurred, the actual amplitude including base load was 2200 A, measured with the automatic fuse.

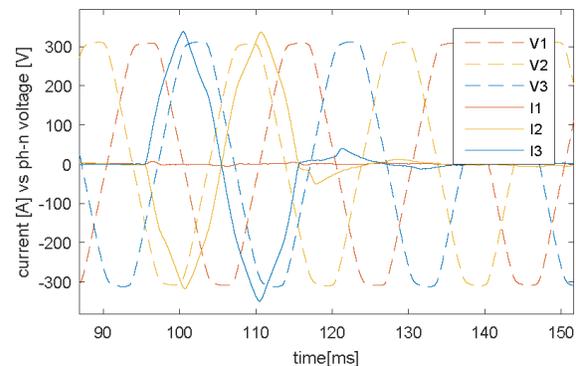
**Fig. 12** - Triggered event on yellow and blue phase recorded at 17-11-2016 with subtracted base load.

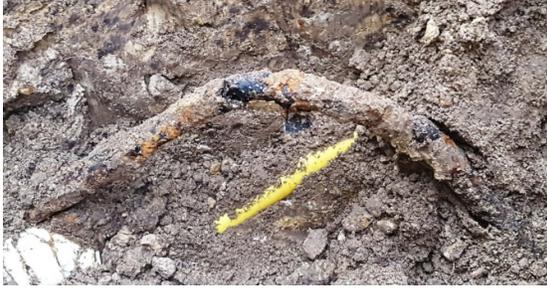
Power issues were repeatedly reported by connected customers. The connection was therefore tested. A cable damage was found in the service cable connected to this customer block at approximately 60 m from the substation, see Figure 13. A recently (less than four years earlier) installed gas pipeline is present underneath the cable, suggesting that the cable could have been damaged during its installation.

**Fig. 13** - Photograph of the damage cable found in the connection monitored in case study 3.
