Heavy Axle Load Track Substructure Research by TTCI

D. Li & D. Read*

Transportation Technology Center, Inc., a subsidiary of the Association of American Railroads, Pueblo, CO, USA (* Retired)

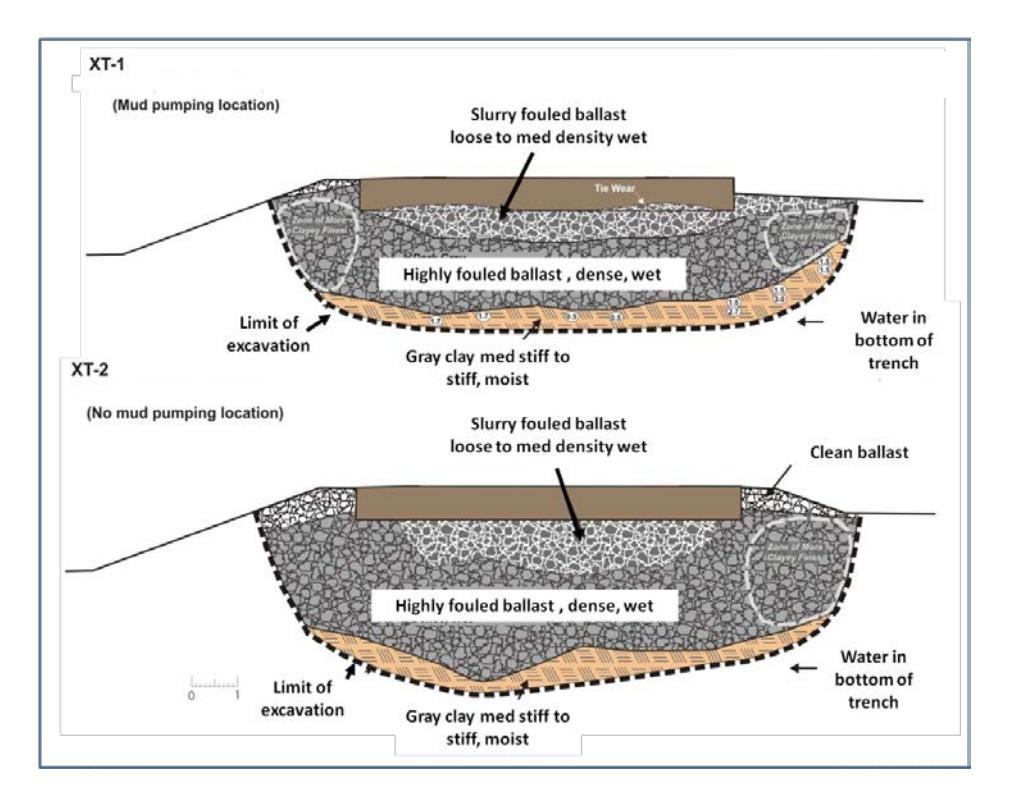
Three cross trenches were dug at Site 1. One trench was dug at the mud spot and labeled XT-1 (Figure 1), and two others were dug at nearby locations where mud was not visible on the surface and labeled XT-2 (Figure 1) and XT-3. The substructure layer conditions at all three trenches were similar, including the following: (1) a top granular layer consisting of loose to medium-dense aggregate that was wet and fouled primarily with mud slurry, (2) a

second granular layer, denser than the top layer, very wet and fouled, but without the mud slurry, and (3) subgrade of moist plastic clay, gray in appearance and moderately stiff at the surface, becoming increasingly stiff a few inches below the subgrade surface. The only difference in the appearance of the three trenches was that the mud slurry in the top layer had pumped through the shoulder ballast at XT-1 to form a mud spot.

Figure 1: Similarity of XT-1 and XT-2 cross sections.

These investigations have also revealed that water trapped in the fouled ballast layer was the main cause of the deterioration. Although well-defined ditches were located next to and below the elevation of the ballast layer, the very low permeability of the fouled ballast shoulder and clay subgrade effectively blocked lateral drainage from the ballast section to the ditch. As a result, the top ballast layer was fouled with mud slurry that, in some cases, was being pumped up around the sides and ends of the ties.

Maintenance activities, such as cribbing to remove fouled ballast between ties, surfacing, and ballast undercutting/cleaning to depths of 12 inches or less, are commonly used to deal with muddy ballast conditions. However, these methods do not necessarily restore adequate permeability of the ballast layer. Installing cross drains or ballast renewals that are deeper than 12 inches below the ties are required to restore the lateral drainage path.

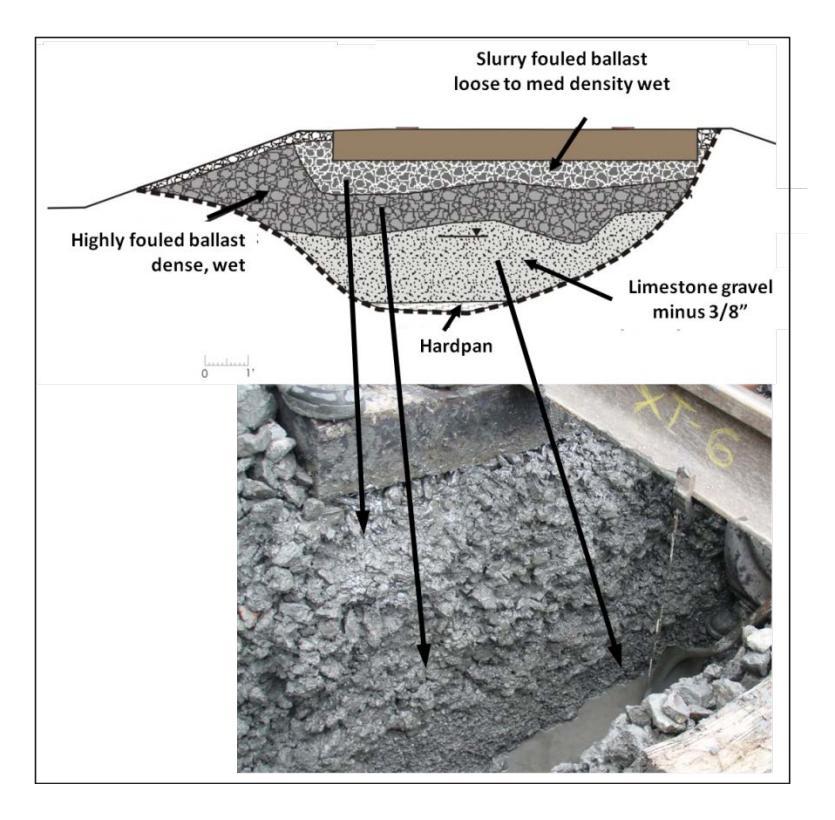
Cross trenches were dug at Site 3. Similar to the other sites, the granular layers were very wet with water collecting in the bottom of the trench, as well as slurry-fouled top layer and a denser, highly fouled second layer. However, there was a third layer of medium-dense granular limestone gravel subballast sitting on a hardpan layer (Figure 2). This site was slightly different from the others in that there was more water present, and the slurry tended to pump through the ballast shoulder near the toe, rather than pumping up around the ties.

Figure 2: Ballast layers at Site 3.
