EXPERIENCES IN THE USE OF LASER SCANNERS AND GPR TECHNIQUES IN FROST DIAGNOSTICS ON ROADS AND STREETS

Timo Saarenketo, PhD
Managing director
Roadscanners Group

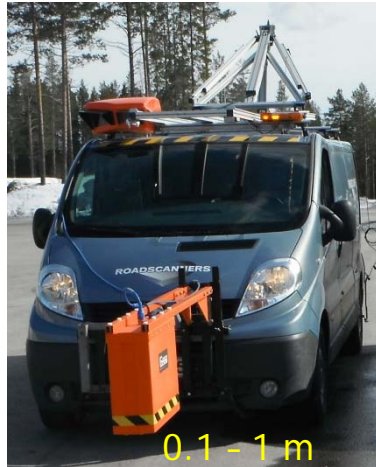
GPR

0.1 - 1 m

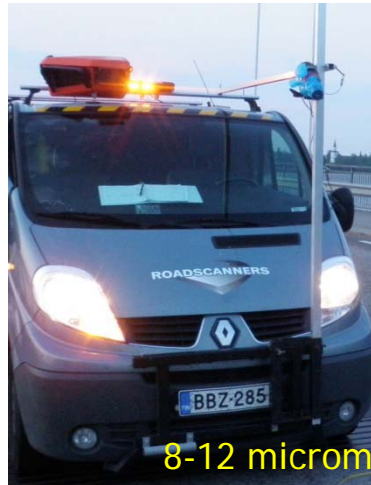
Thermal Camera

8-12 microm

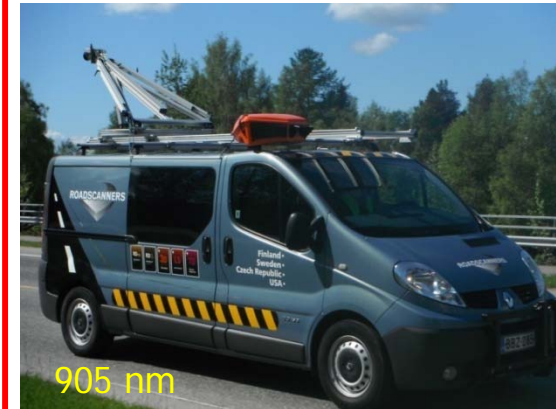
Laser Scanner

905 nm

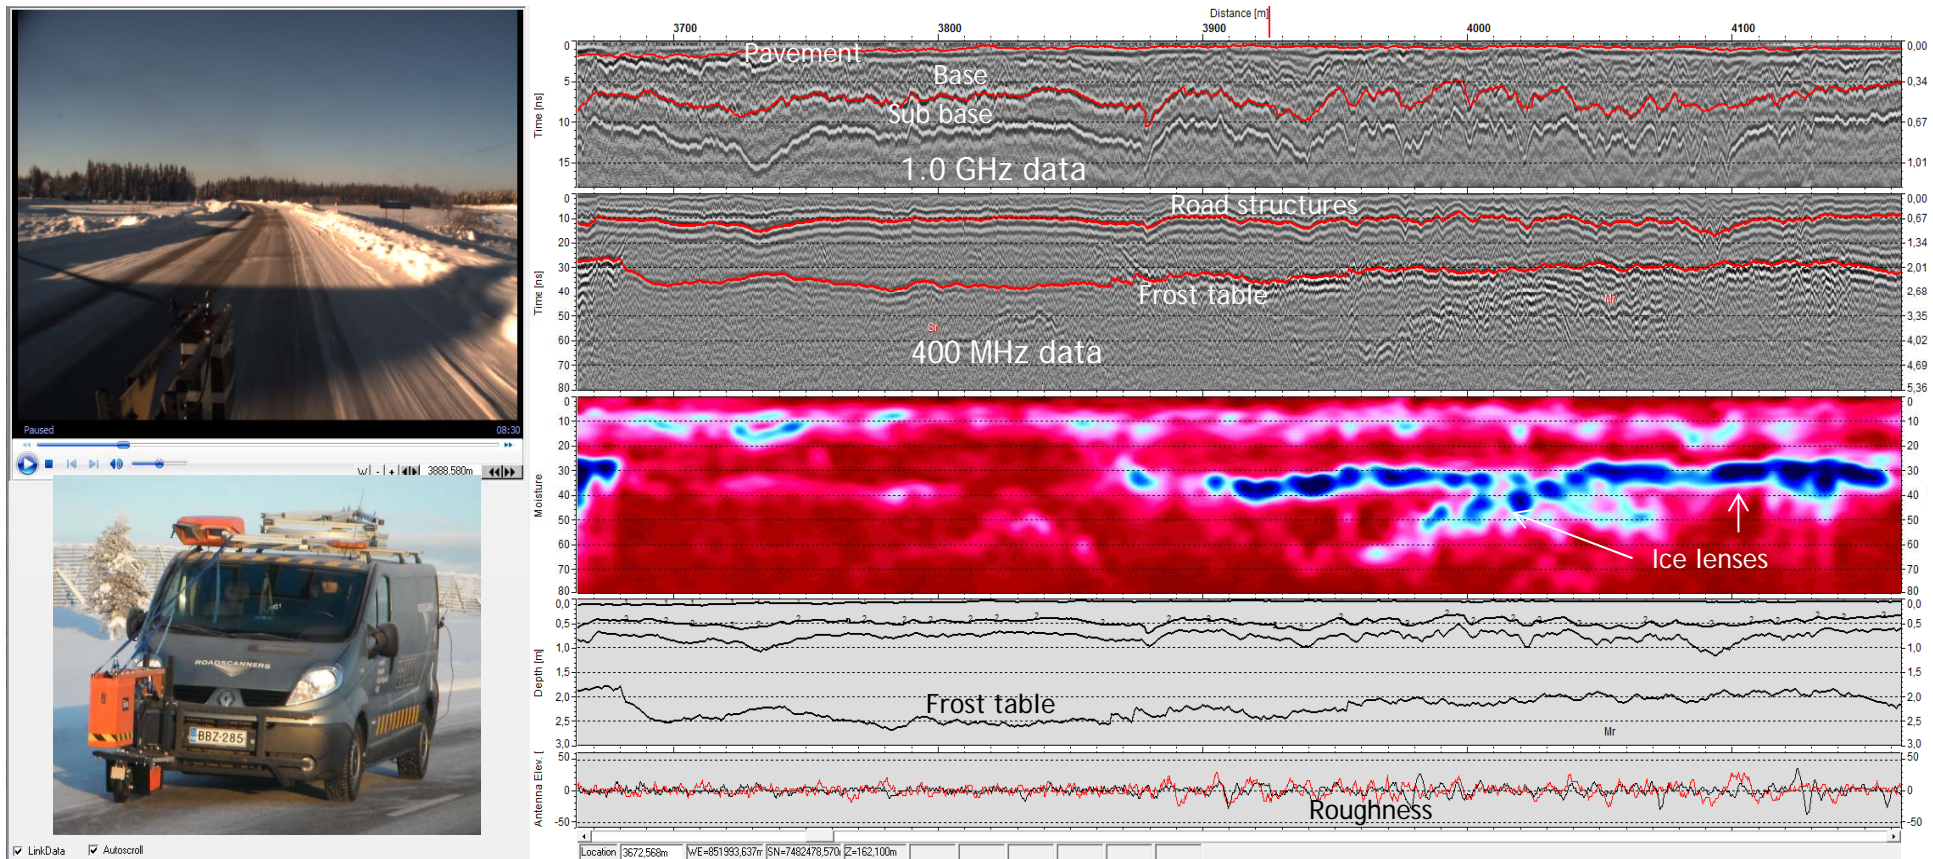
2D GPR FROST ANALYSIS IN WINTER

Detection of unfrozen water (ice lenses) in frozen ground

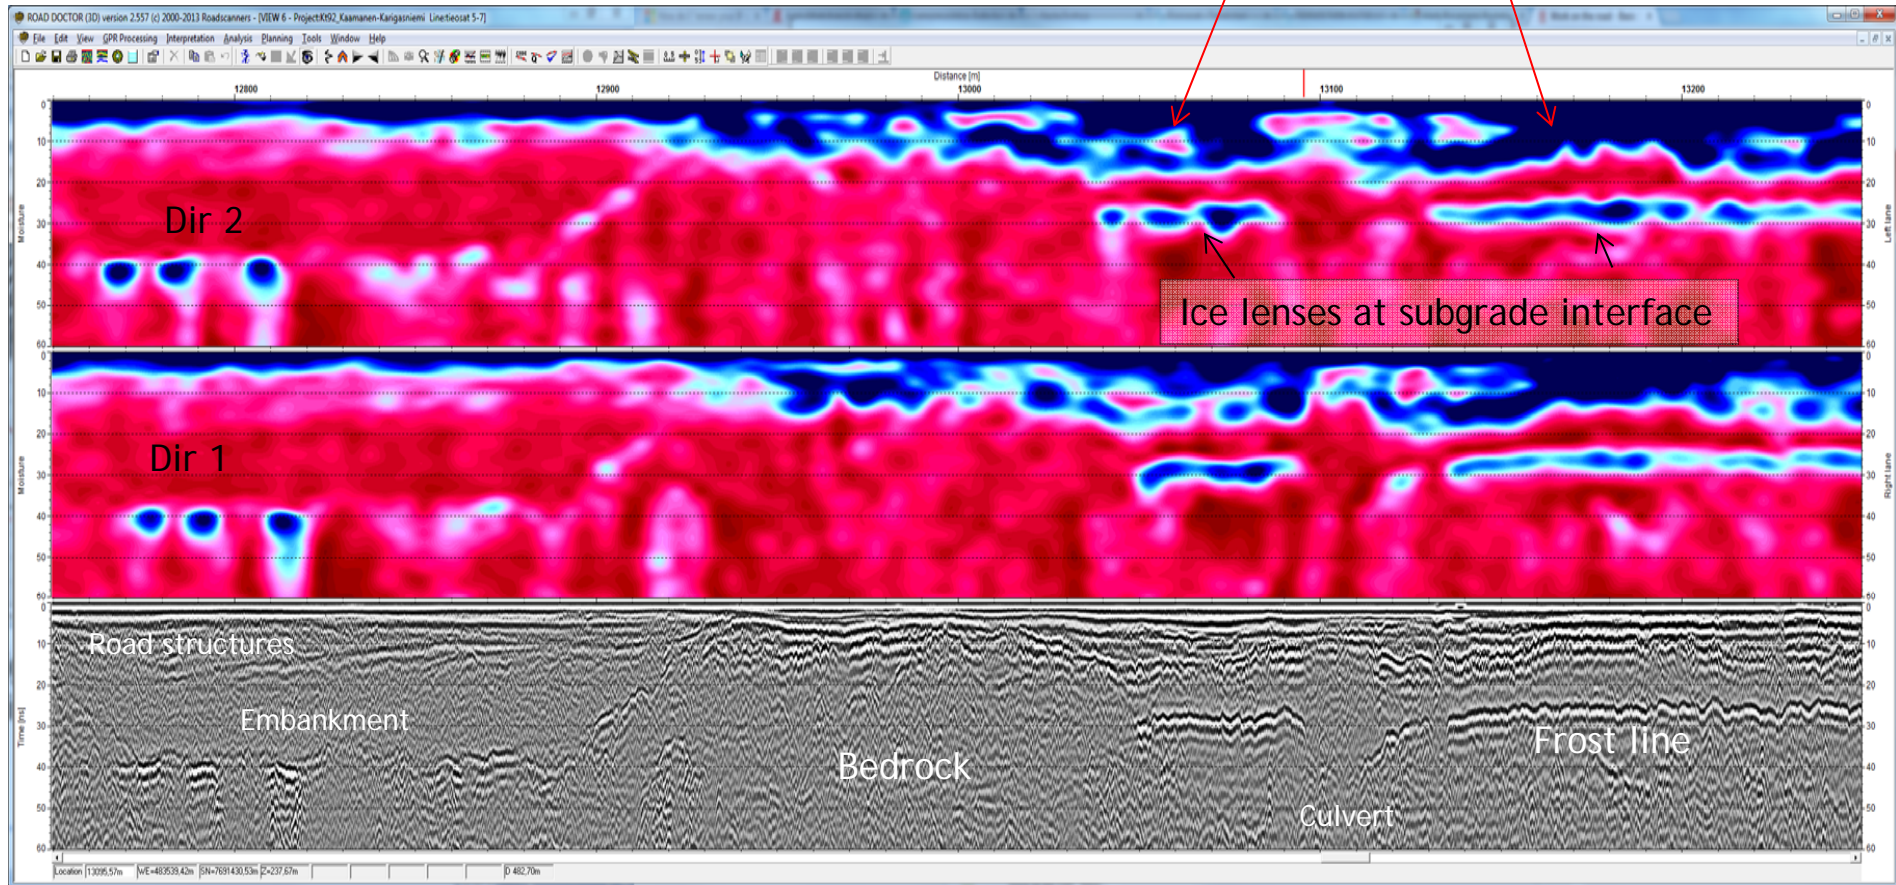
EXAMPLE OF GPR FROST ANALYSIS: RD 92, FINLAND

400 MHz GPR data

Ice in road structures

Small risk for deformations

Bedrock close road surface -
high risk for Mode 1 rutting

High risk for both Mode 1 and Mode 2
rutting during spring thaw

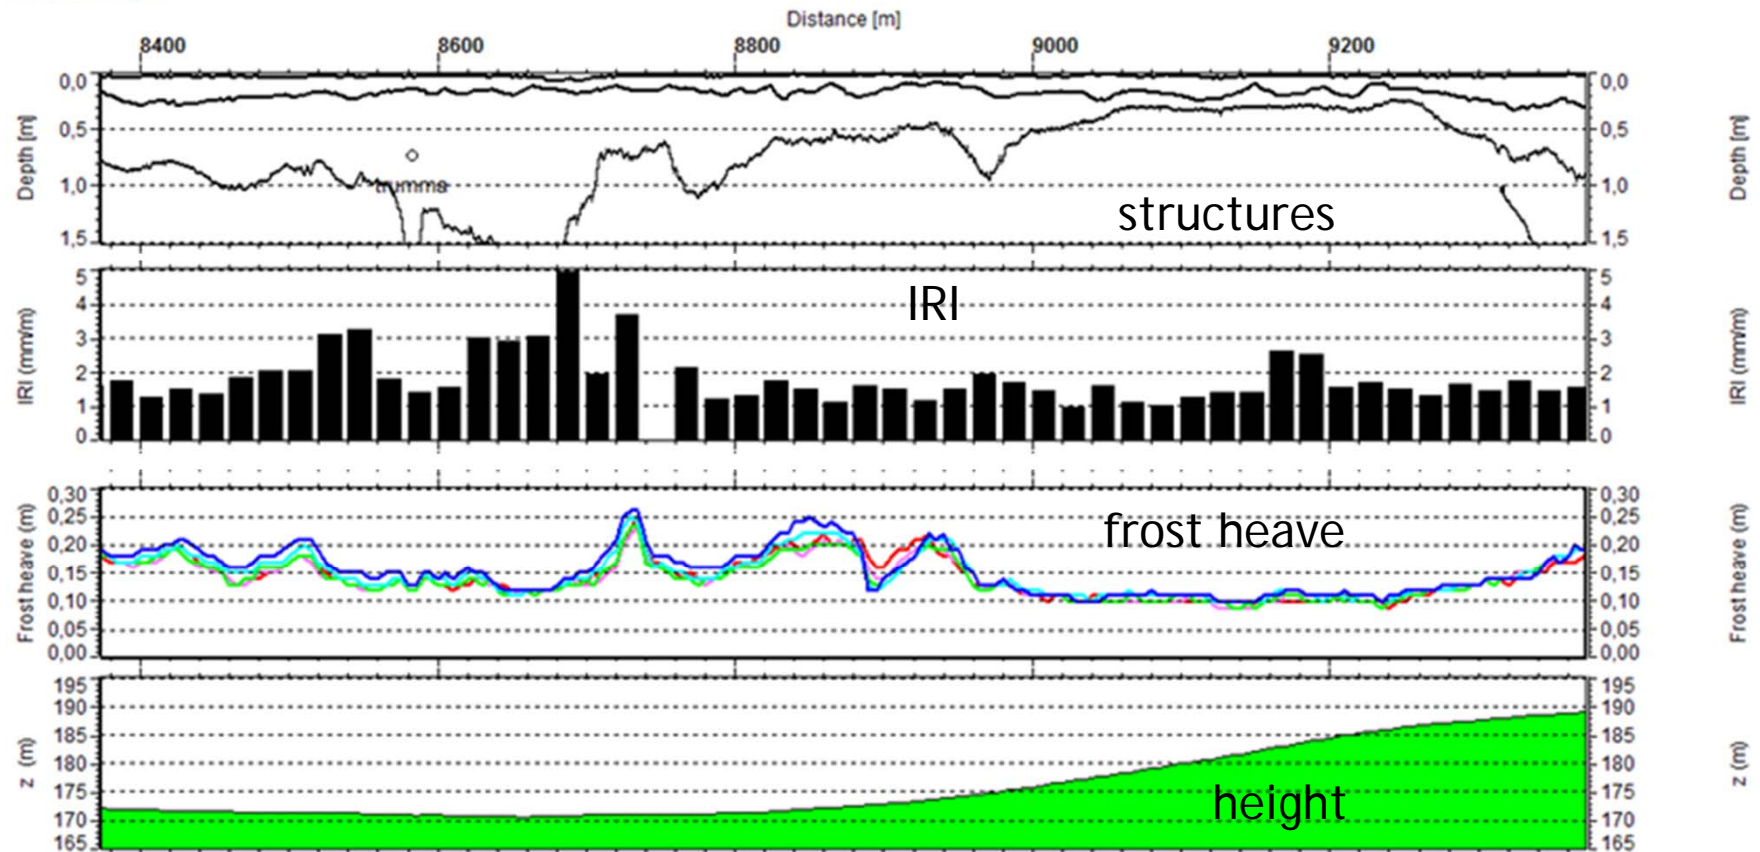
FROST ANALYSIS - RD 99 SWEDEN

Sektion 1 Väg 99

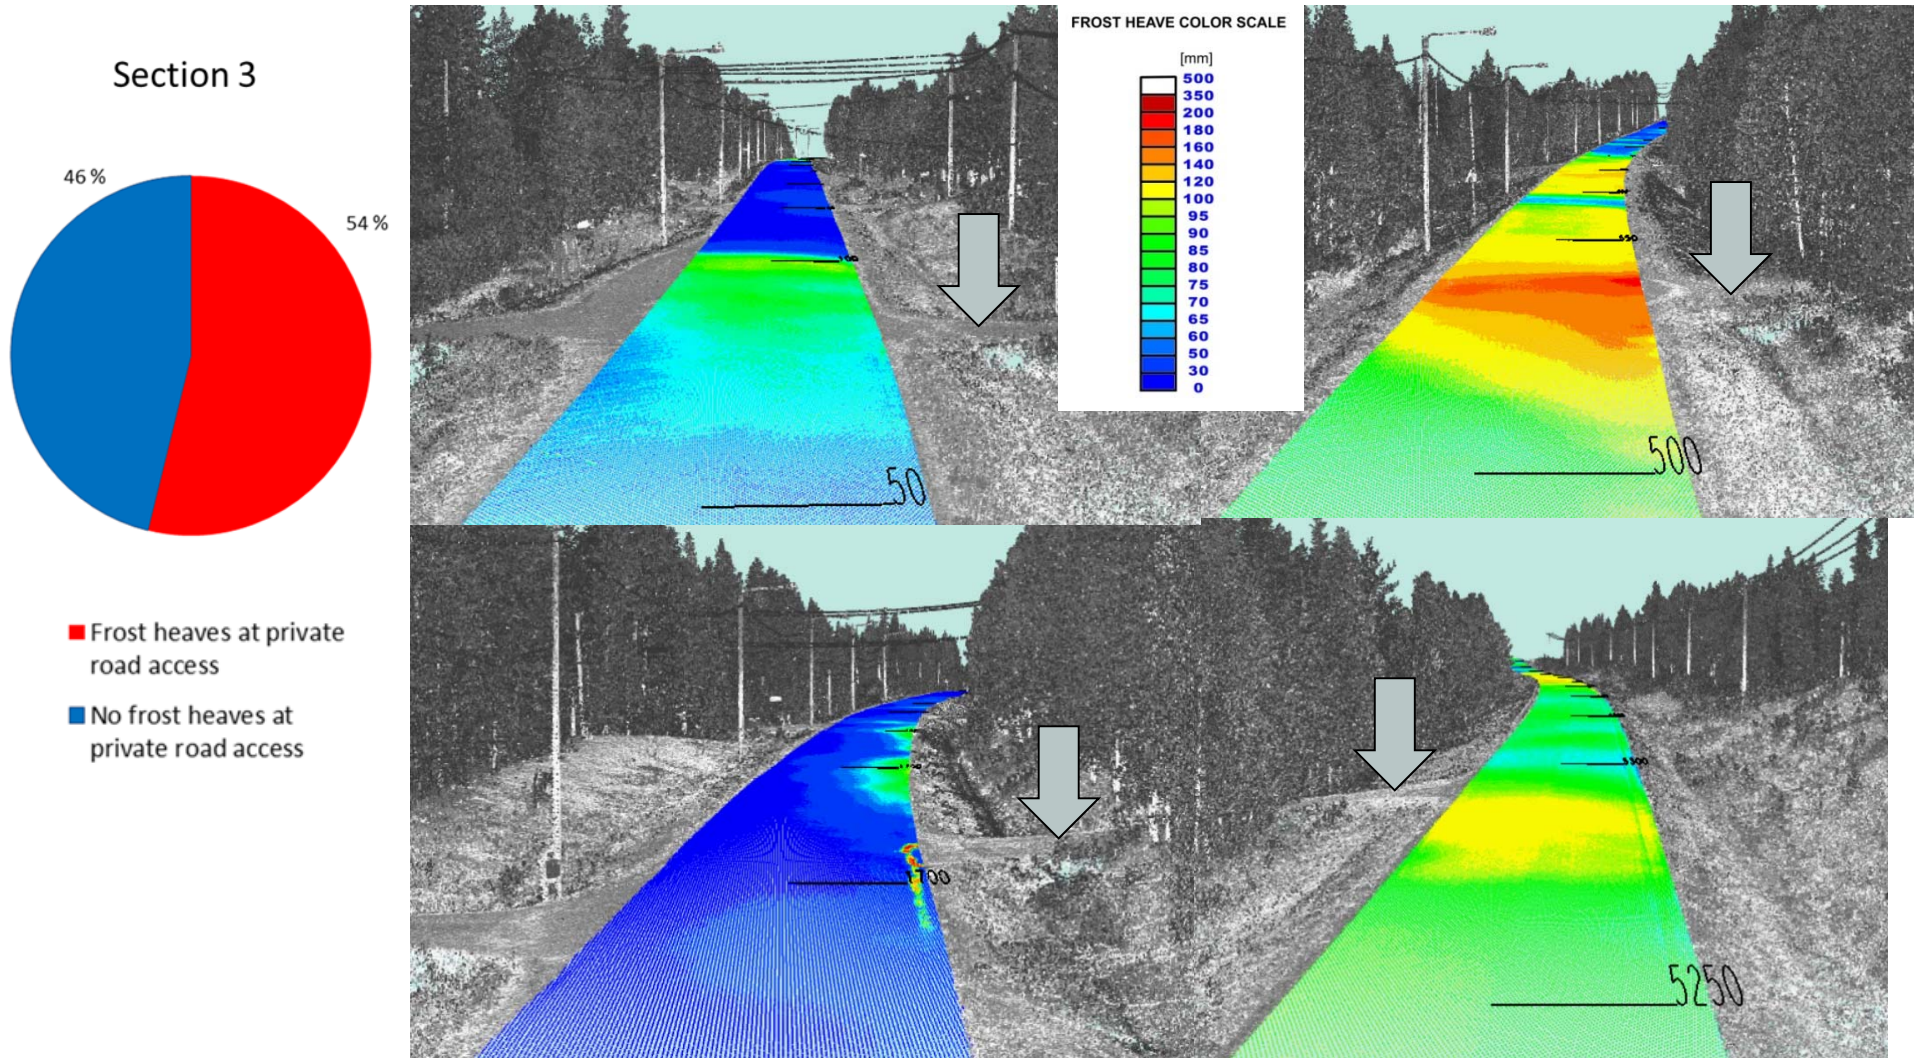
Frost Heave Diagnostics Findings:

Great Amount of Frost Heave Problems can be Related with Private Access Roads

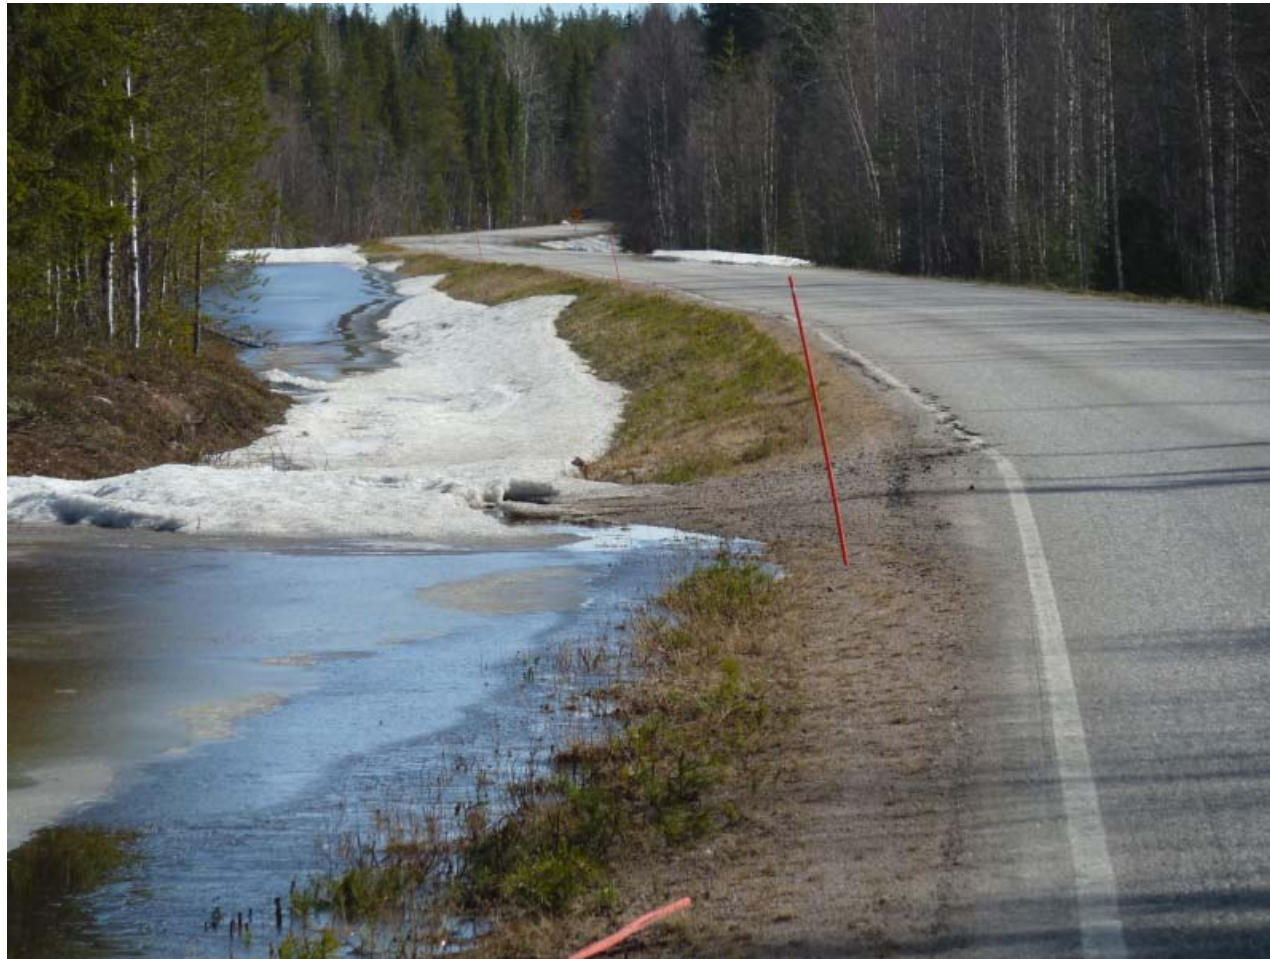
Frost Heave Diagnostics Findings:

Special problem: Glogged Private Acces Road Culverts

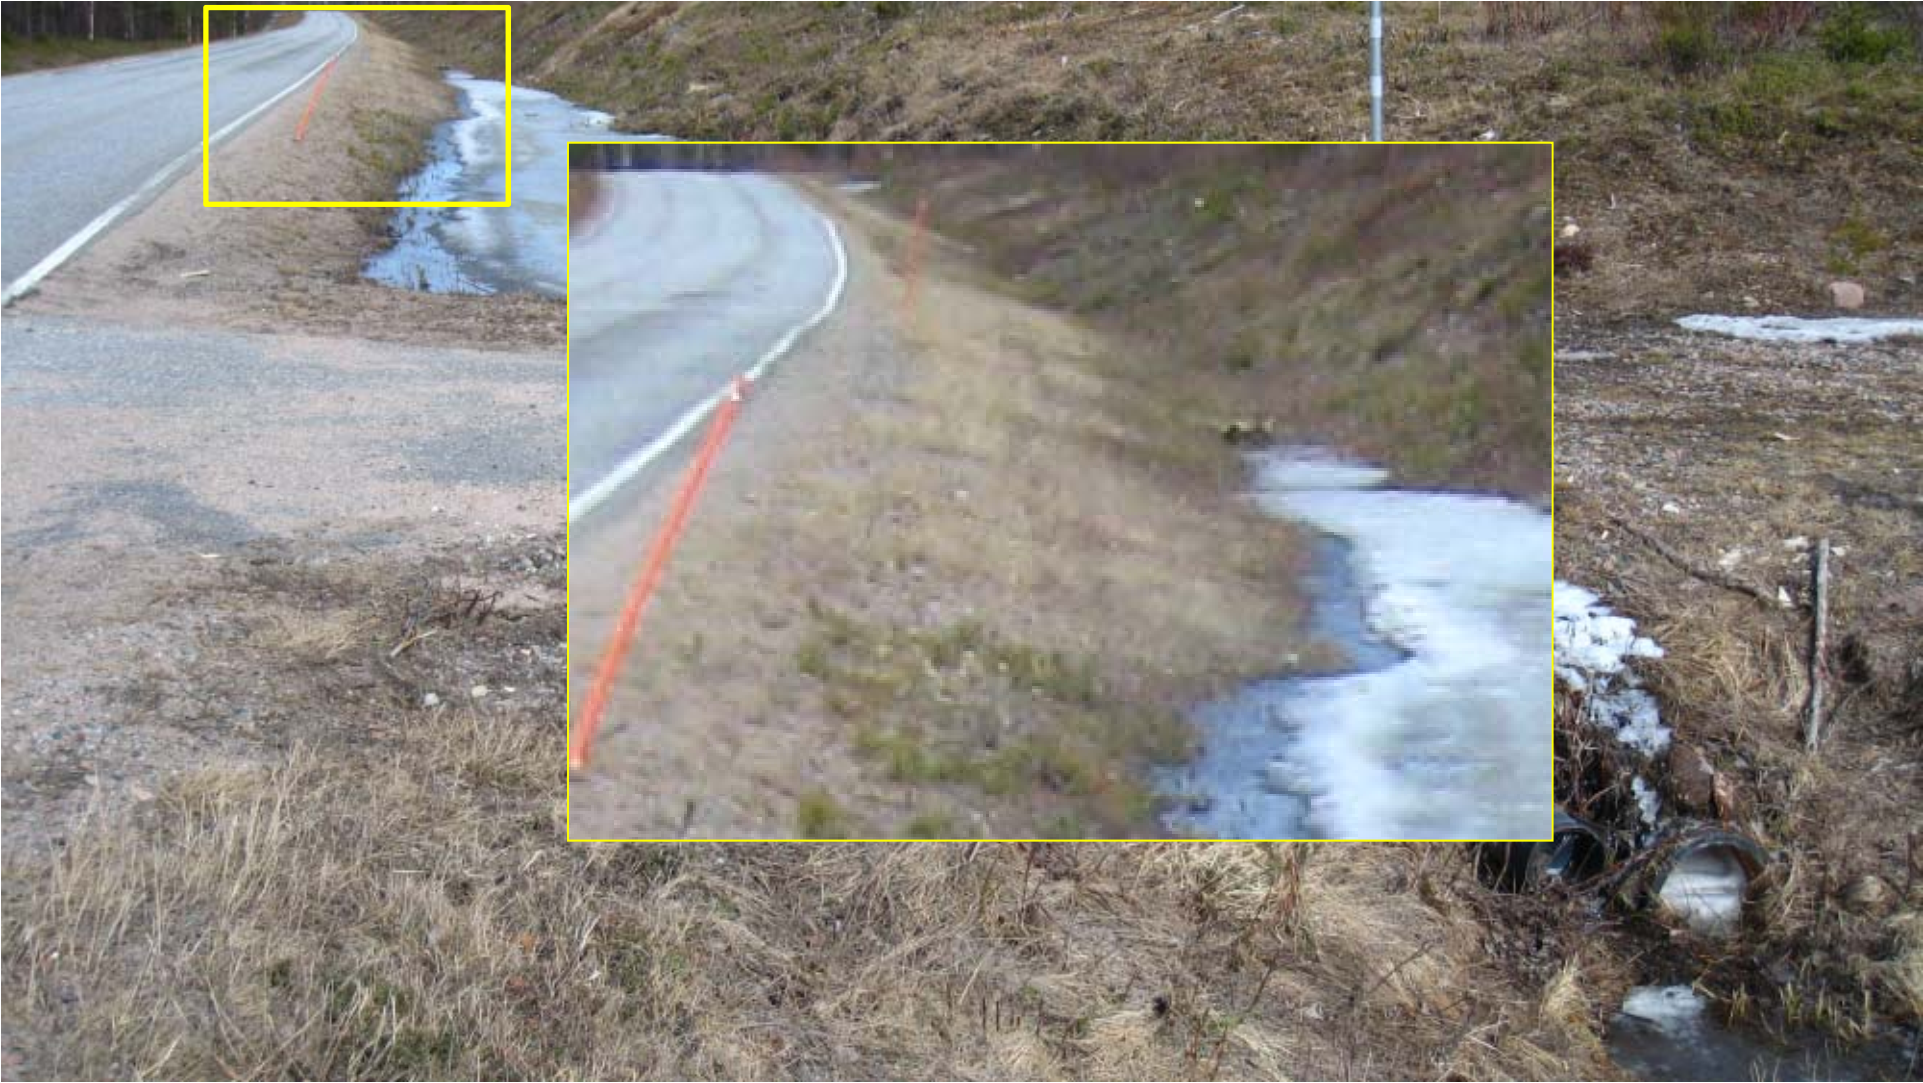
Differential frost Heave at the End of Flooded Ditch
