RAPPORT ARKEOLOGISK SERIE : 2002-1

Monitoring the In Situ Archaeological Deposits at Schultzgt. 3-7, Trondheim, Norway (1996-2001)

Elizabeth E. Peacock

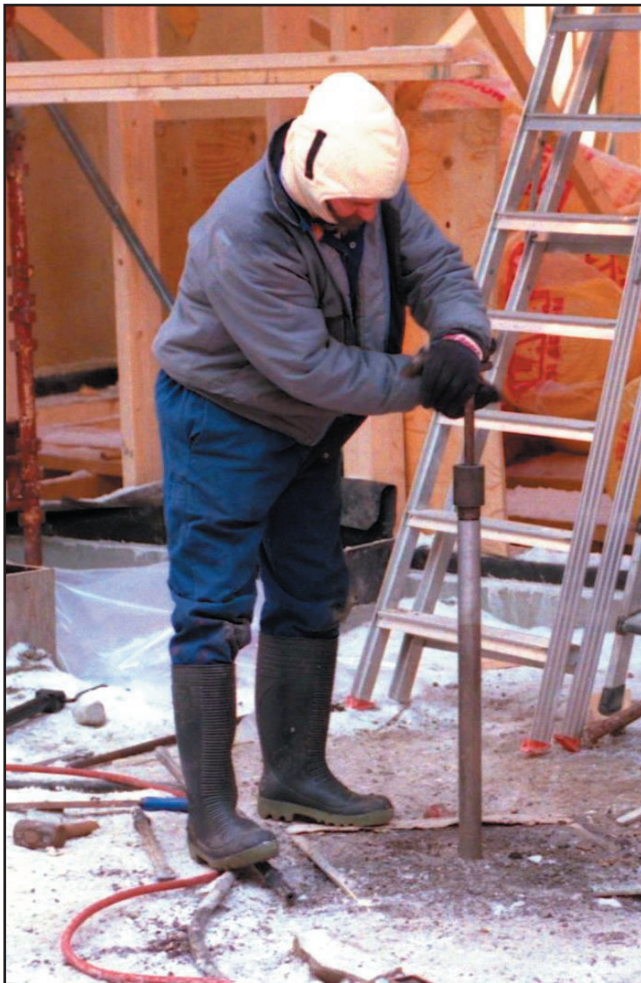
Figure 29 Coring of borehole with hand-held auger system for neutron probe aluminium access tube (E. E. Peacock).

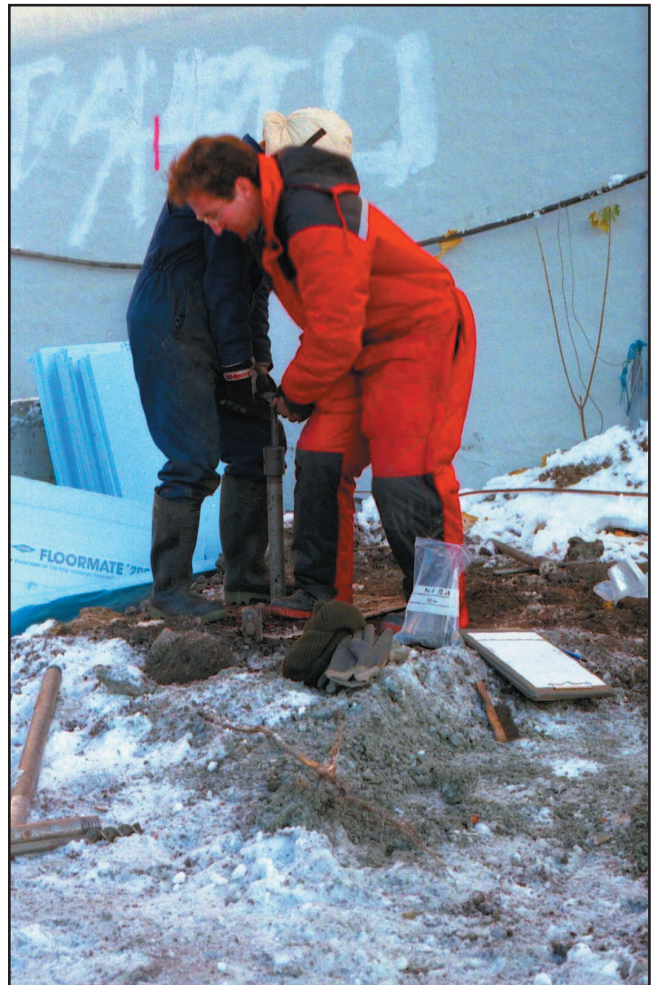
Figure 30 Recovery of core deposit samples for textural description and laboratory analysis (E. E. Peacock).

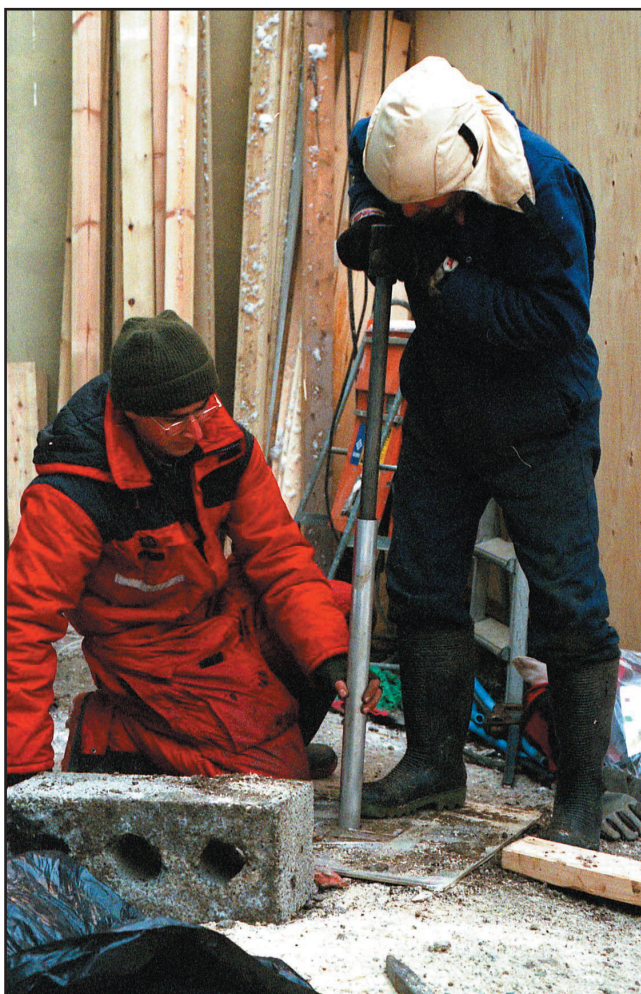
Figure 31 Installation of neutron probe aluminium access tube (E. E. Peacock).

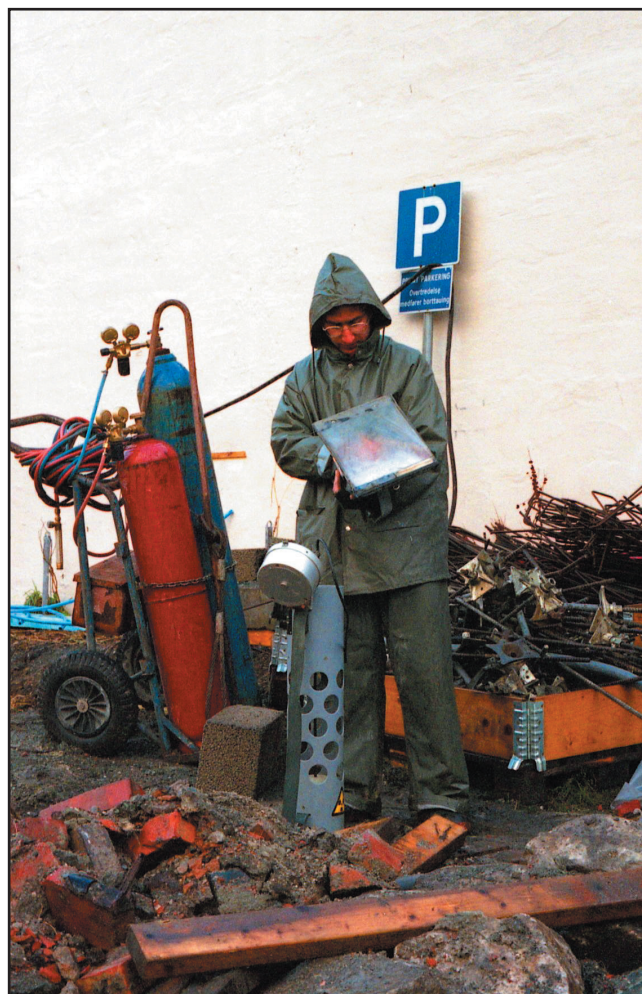
Figure 32 The first readings being taken with the neutron probe directly following installation in November 1996 (E. E. Peacock).

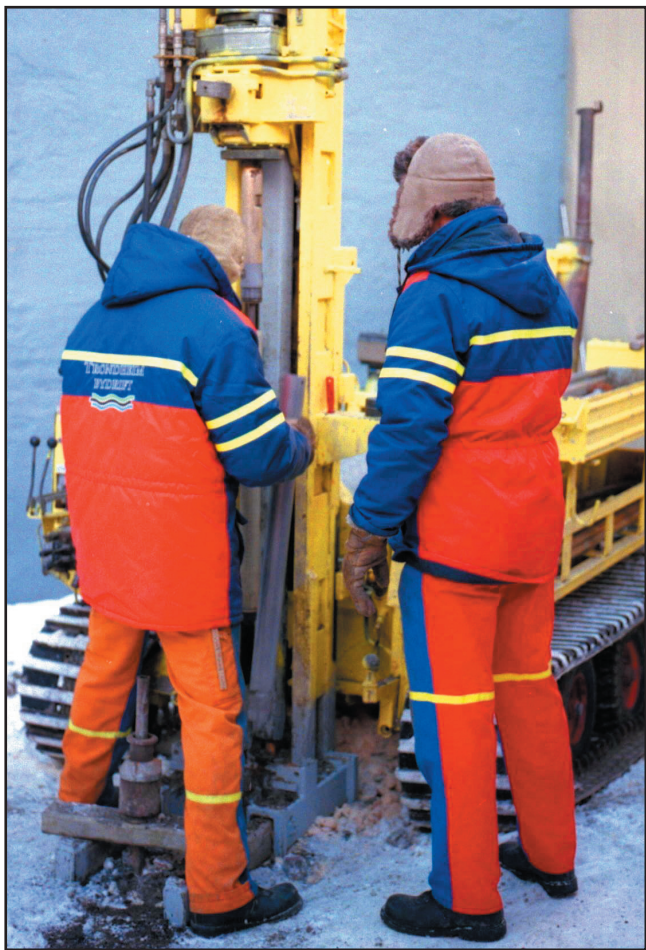
Figure 33 Use of track-mounted mechanical auger for creation of water sampler boreholes (E. E. Peacock).

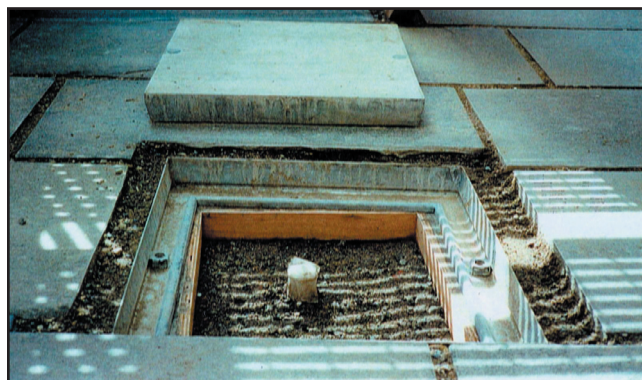
Figure 34 Protective chamber around neutron probe access tube (Hunting 1997).

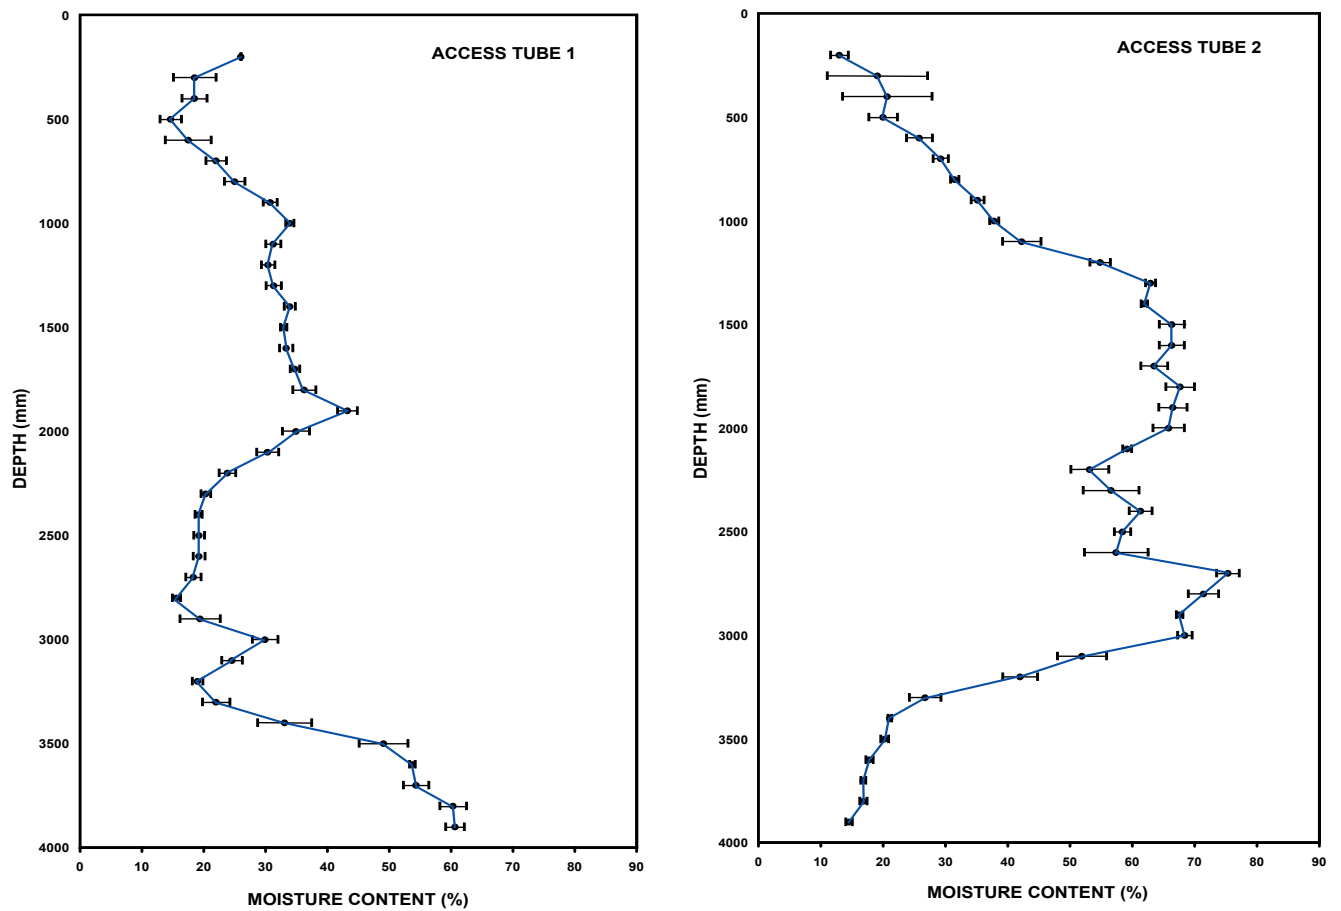
Figure 41a Variation in moisture profiles for Access Tubes 1 & 2 (Schultzgt. 3) for the period 1996-2001.
