Measuring Frost and Frost Action on Roadways

Timo Saarenketo, PhD, Adj.Prof.
CEO, Roadscanners Group

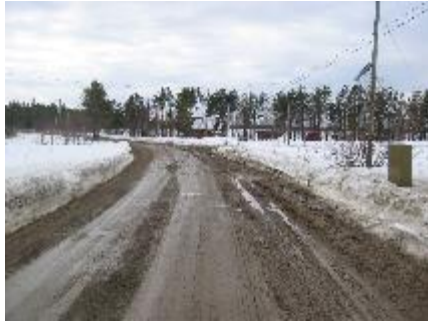
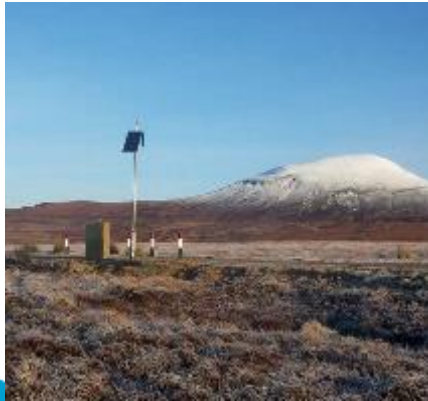
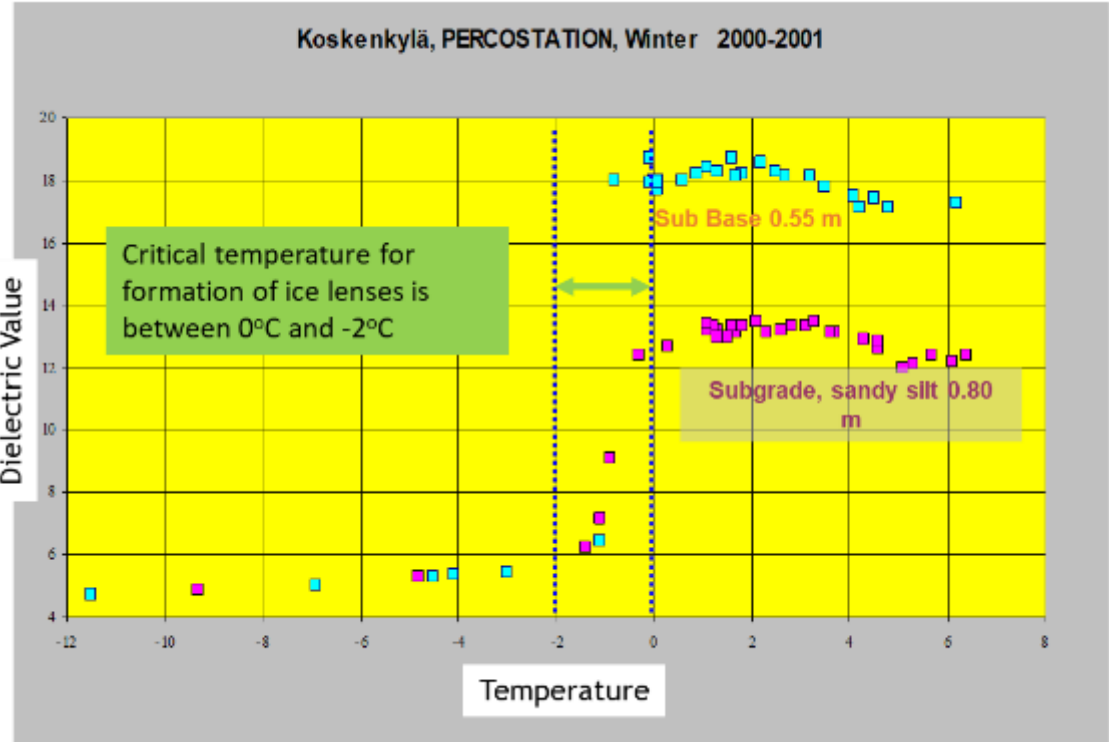
Percostation for Frost Monitoring and Spring Thaw Weakening Monitoring Since 2000

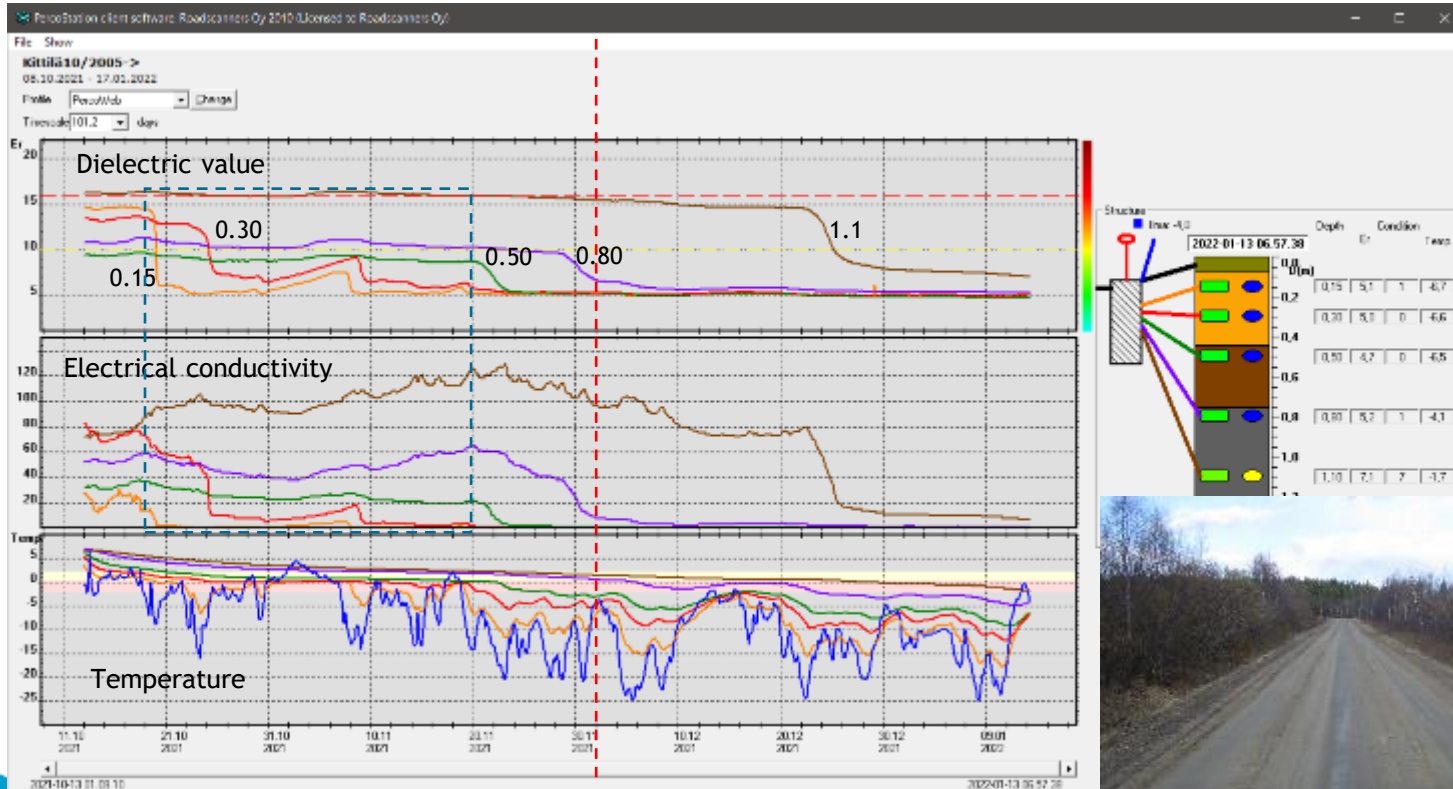
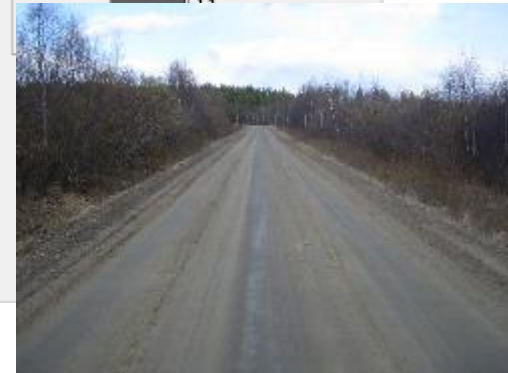
Percostation Data Kittilä Finnish Lapland Fall 2021

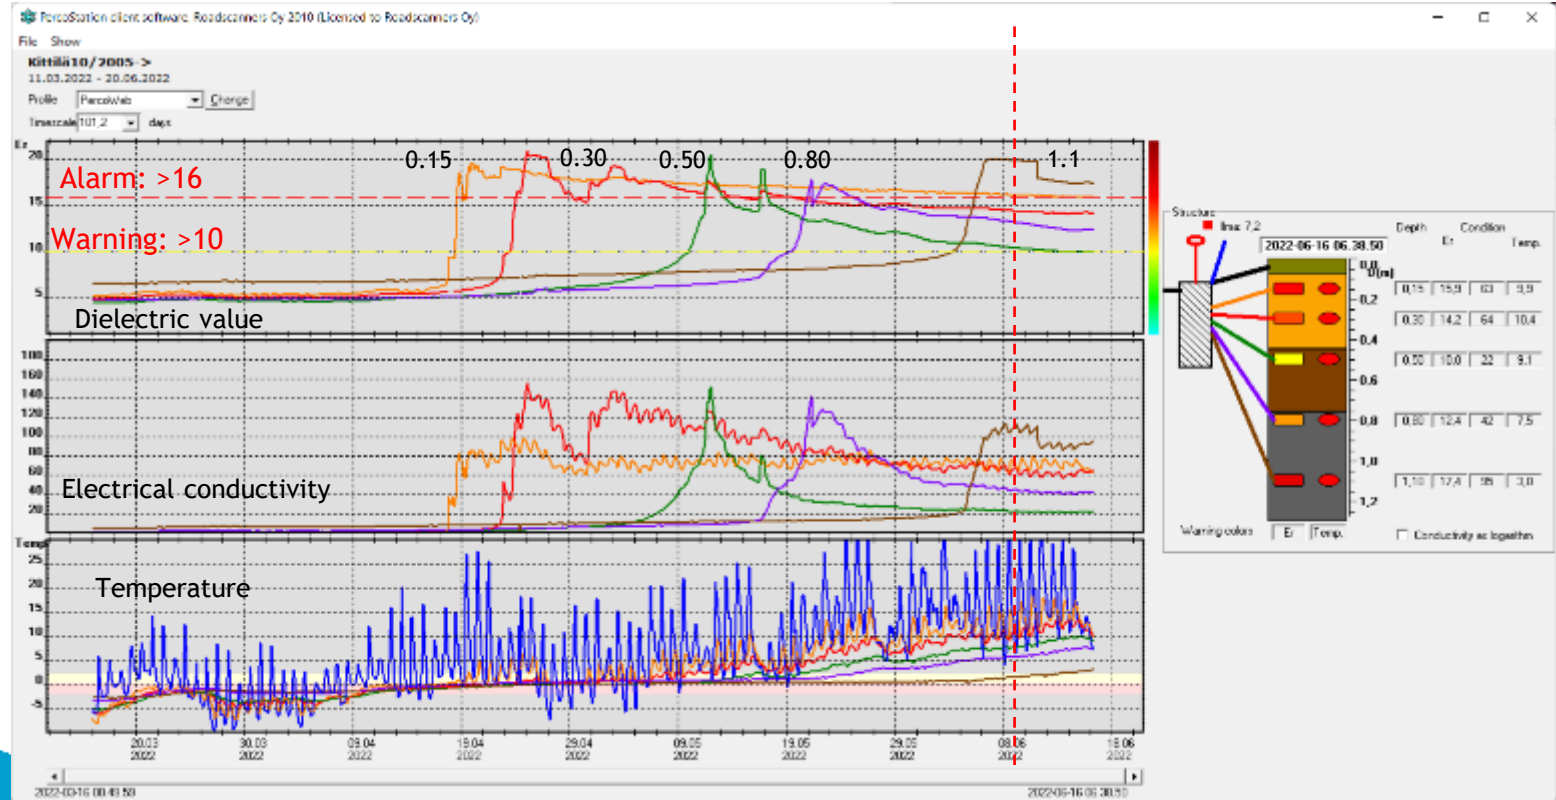
Percostation Data Kittilä Finnish Lapland Spring 2022

Gravel Road with Spring Thaw Weakening Problems

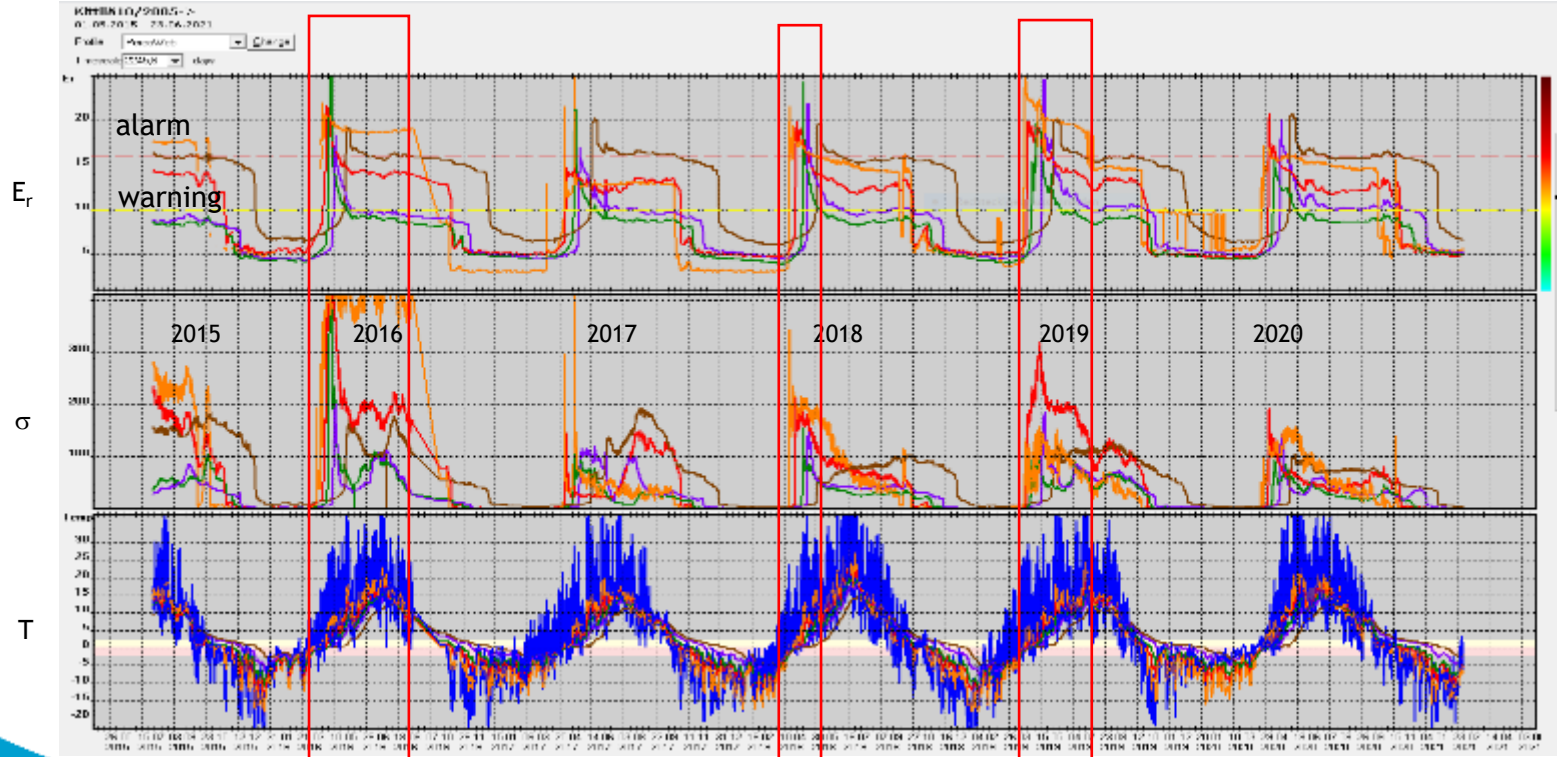
Percostation Data Kittilä Finnish Lapland 2015 - 2021

Gravel Road with Spring Thaw Weakening Problems

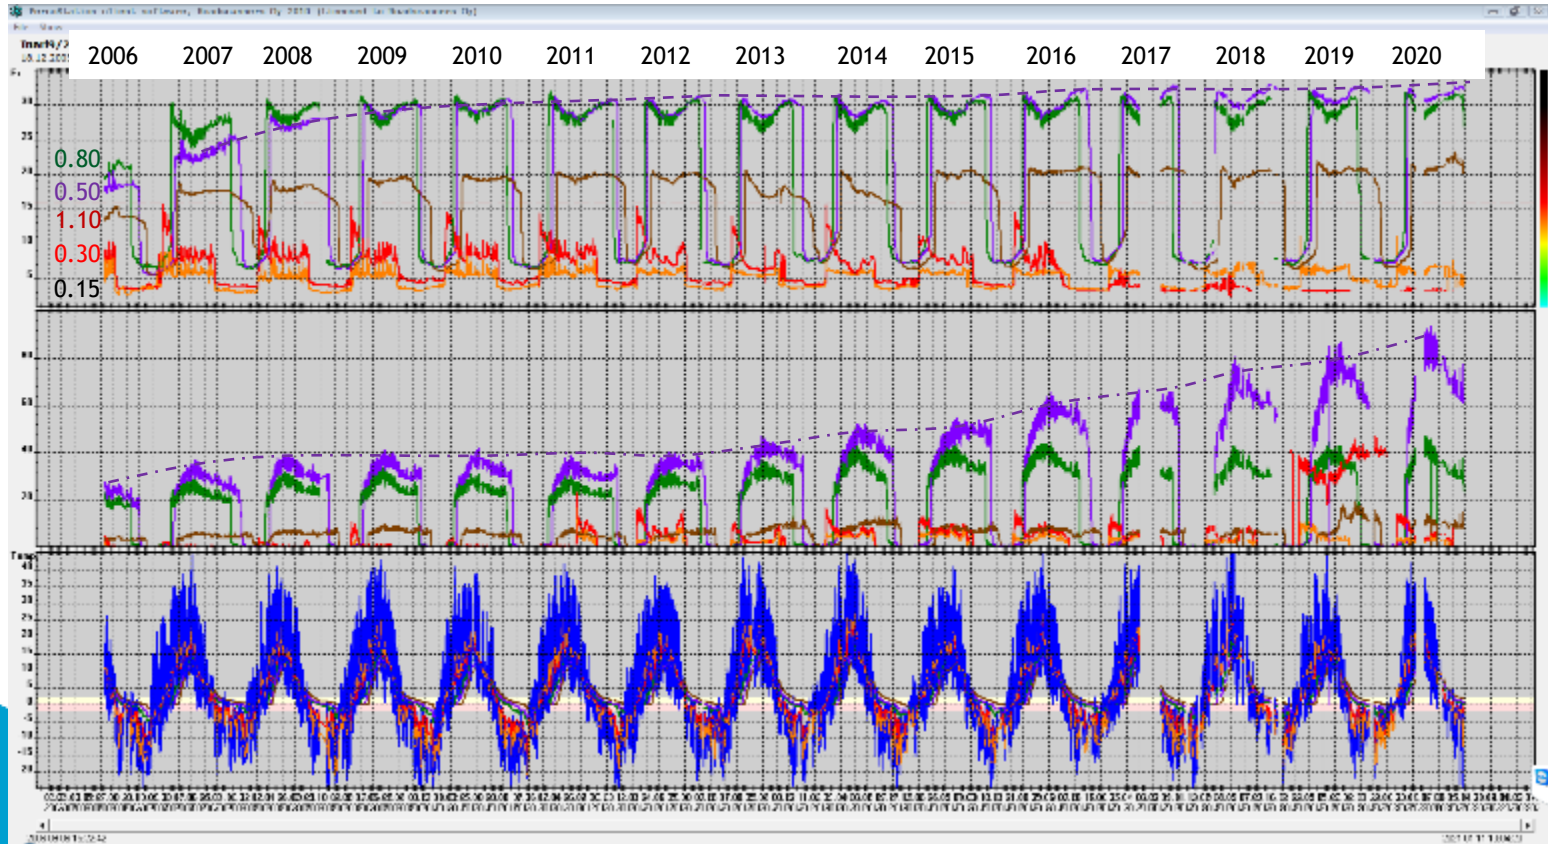
Percostation Data Inari Finnish Lapland 2006 - 2020

Paved Road on Weak Subgrade with Spring Thaw Weakening Problems

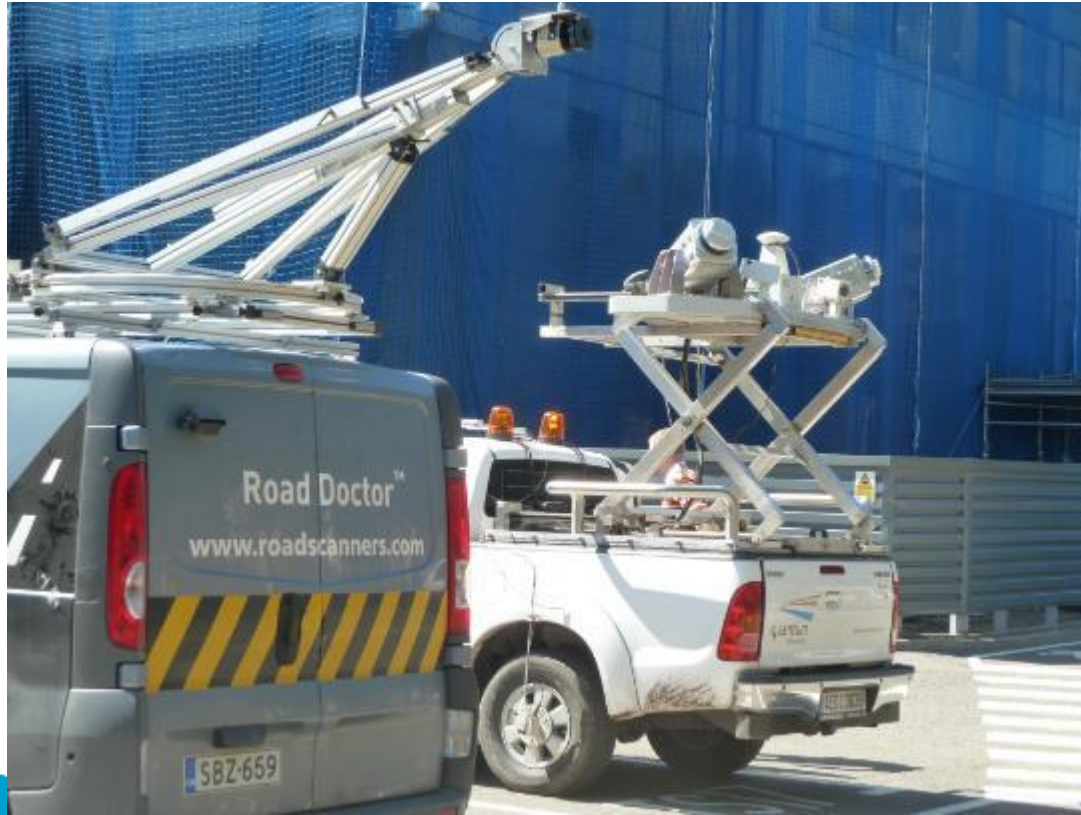
LASER SCANNER (LIDAR) TECHNIQUES IN DIFFERENTIAL FROST HEAVE SURVEYS

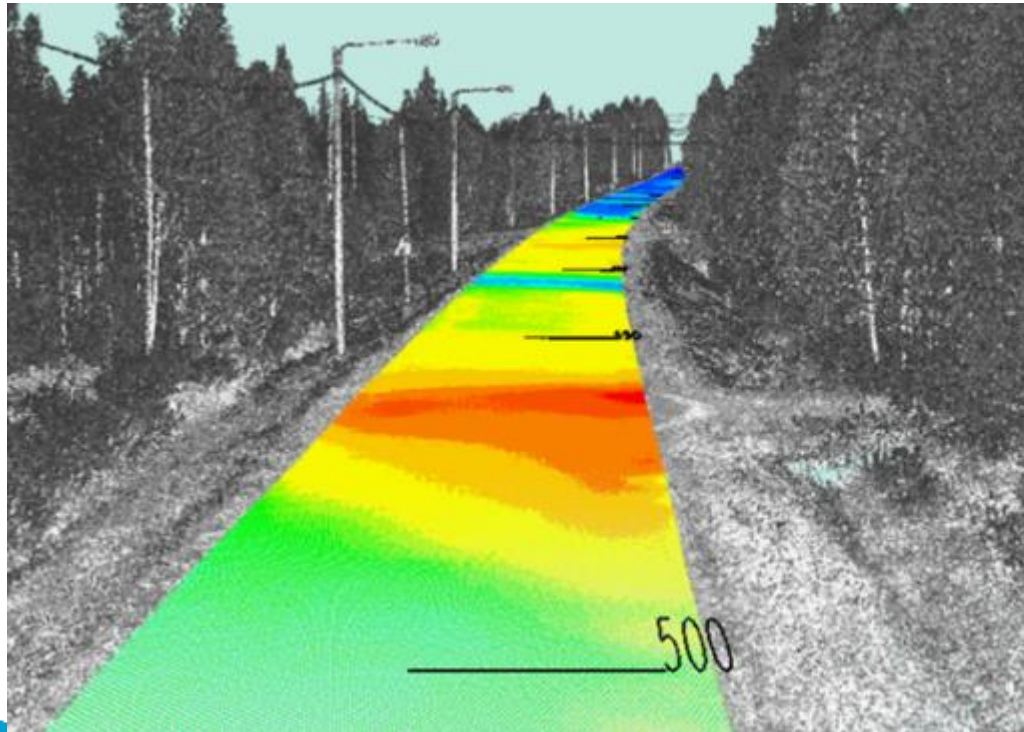
3d Mobile Mapper Based Frost Heave Diagnostics

Private Access Road Junction

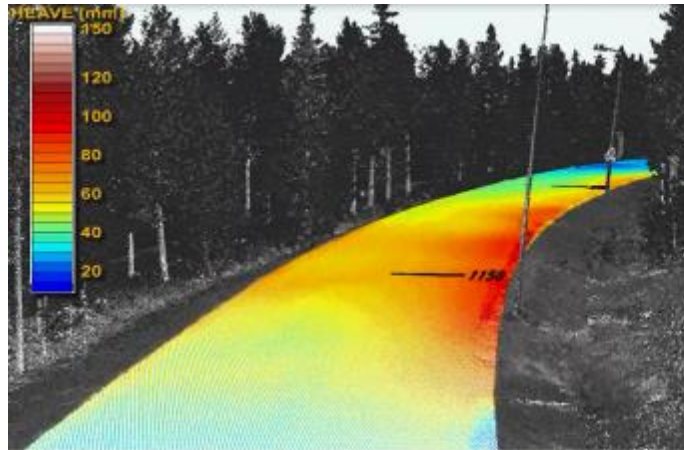
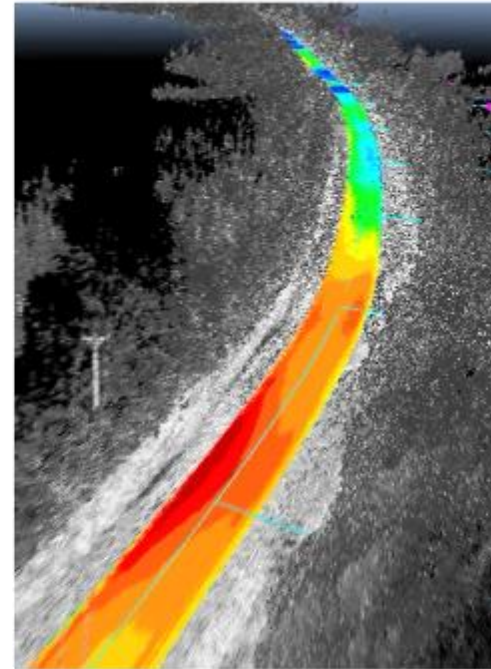
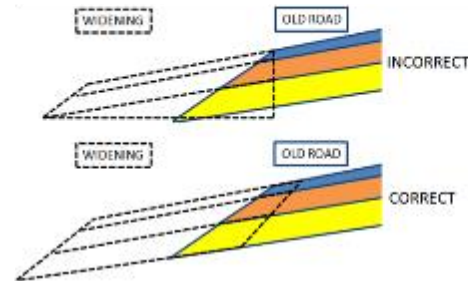
3d Mobile Mapper Based Frost Heave Diagnostics

Frost Heave in Inner Curve

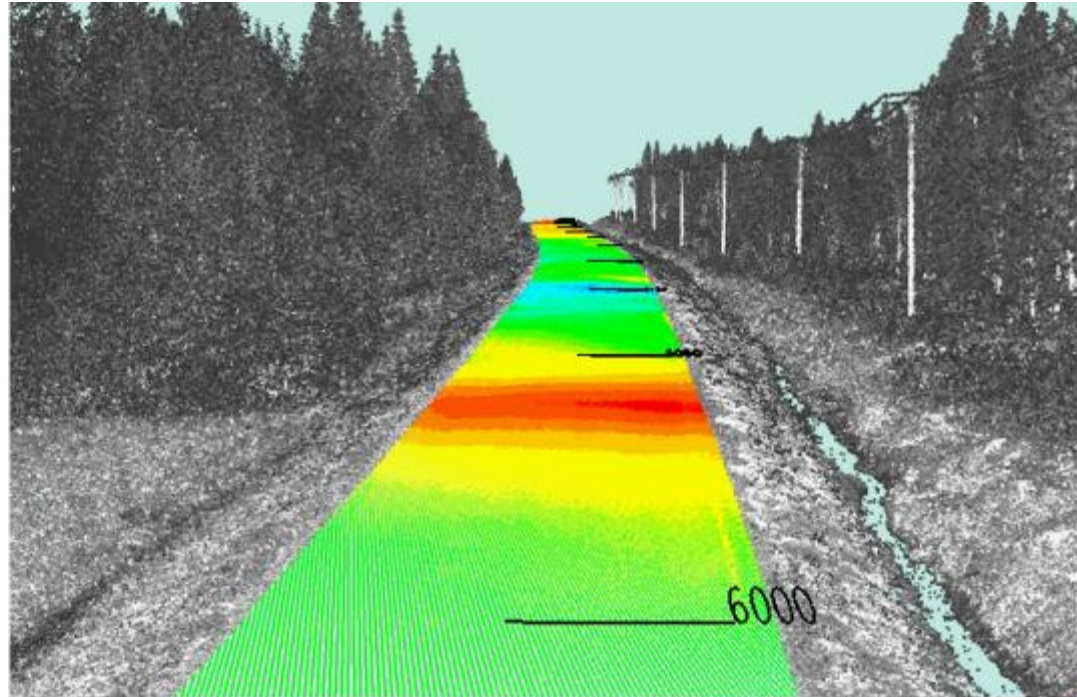
3d Mobile Mapper Based Frost Heave Diagnostics

Missing Transition Wedge Structure

Frost heave
(mm)

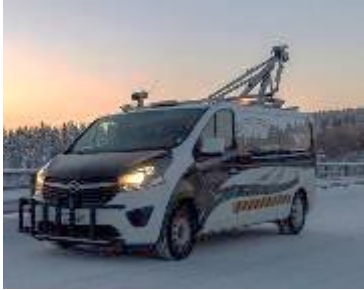
Monitoring Differential Frost Heave with RDSV Lidar

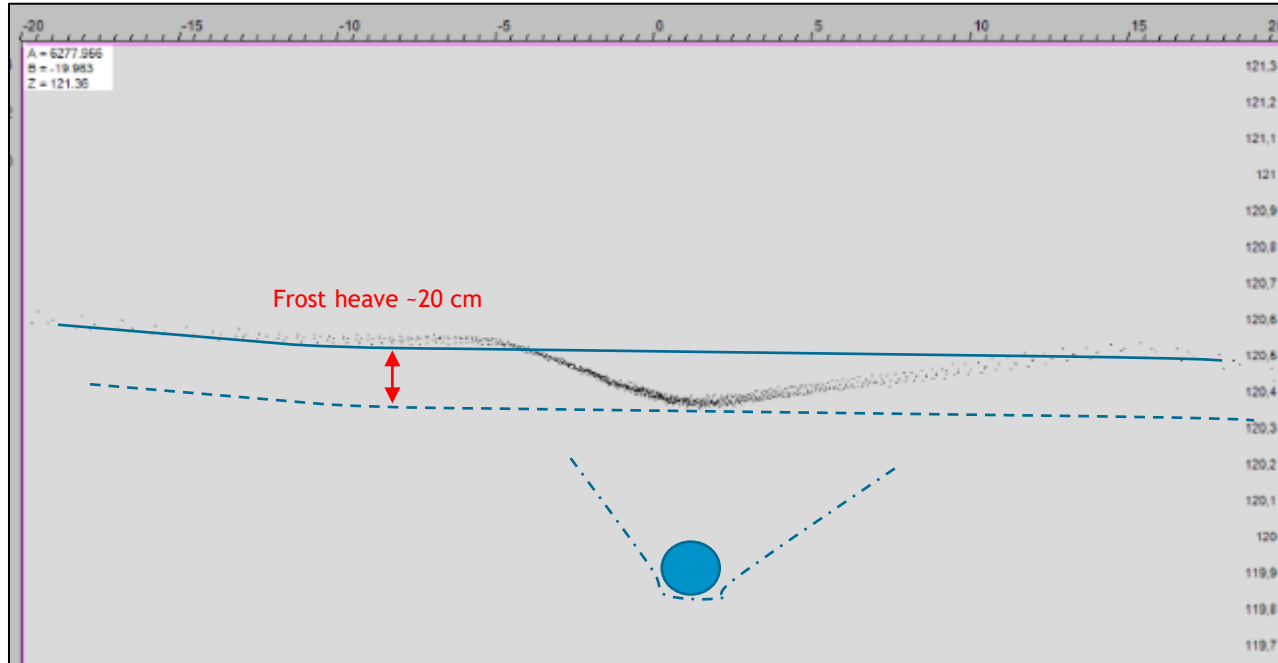
Monitoring Frost Heave with RDSV Lidar

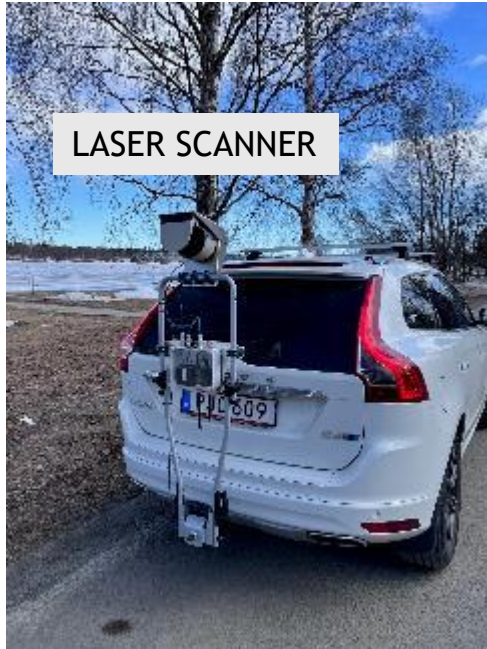
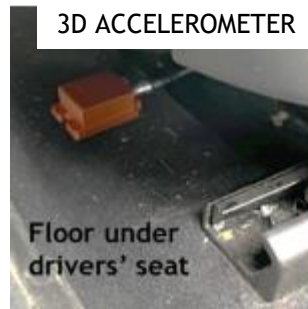
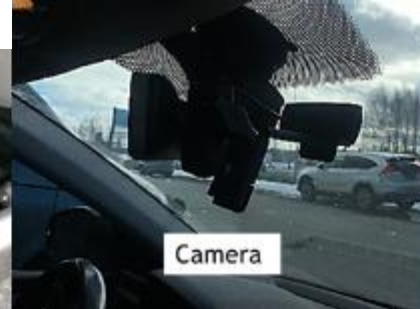
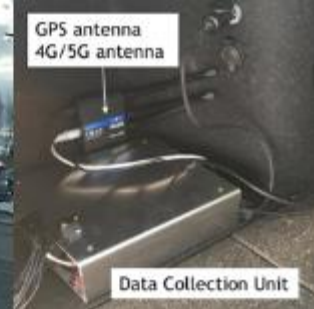
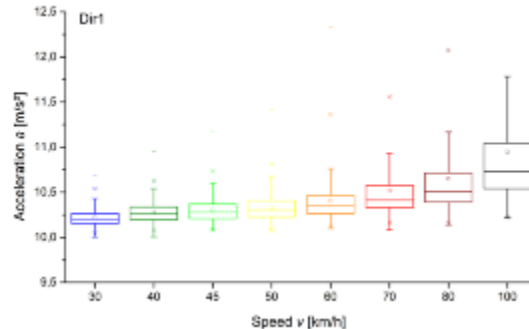
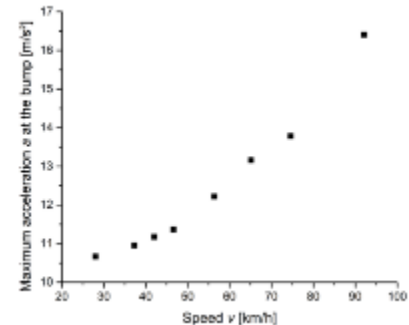
RDMC TECHNIQUE IN REAL TIME MONITORING OF ROAD ROUGHNESS AND RUTTING

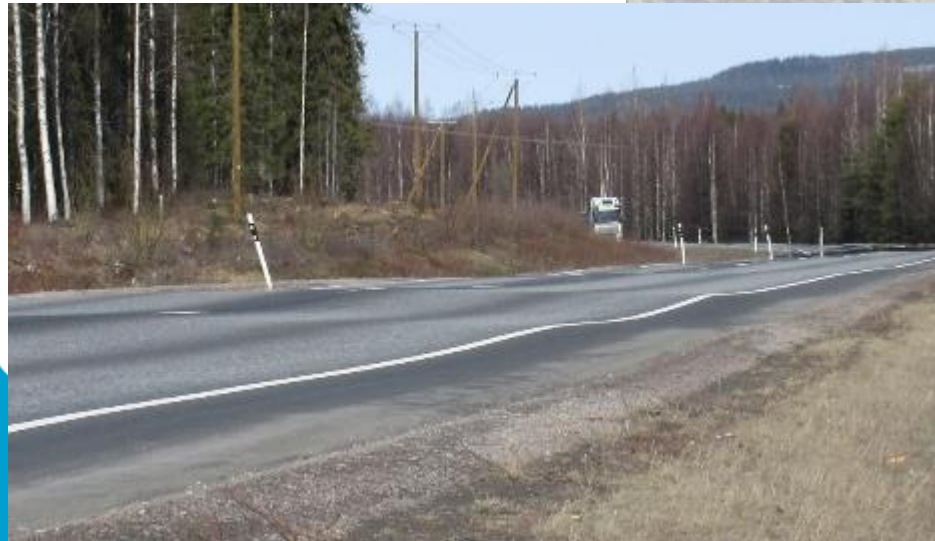
DETECTING DIFFERENTIAL FROST HEAVE SECTIONS WITH RDMC

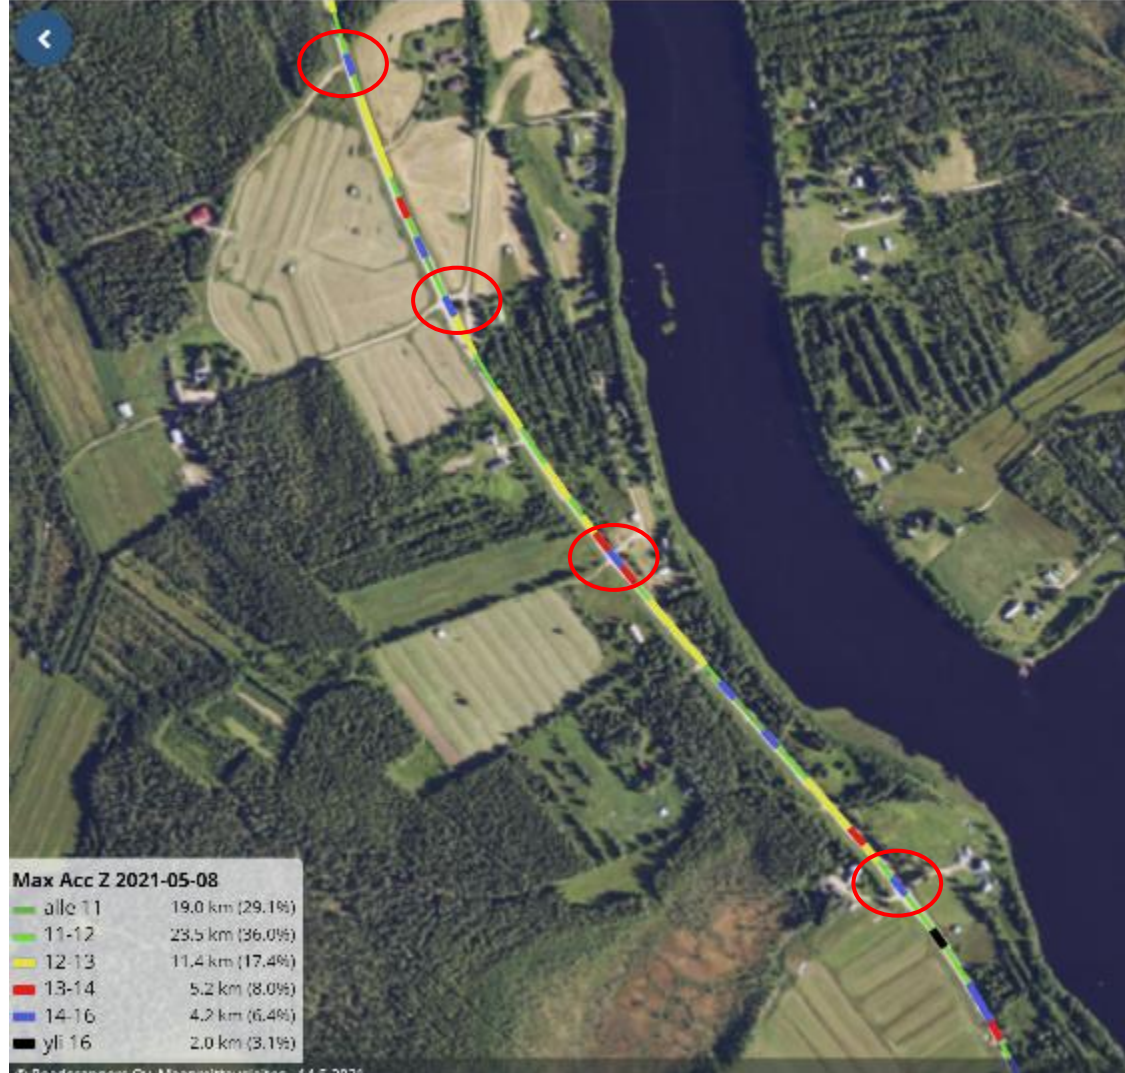
Roughness Diagnostics – Presenting RDMC Data on Aerial Photos

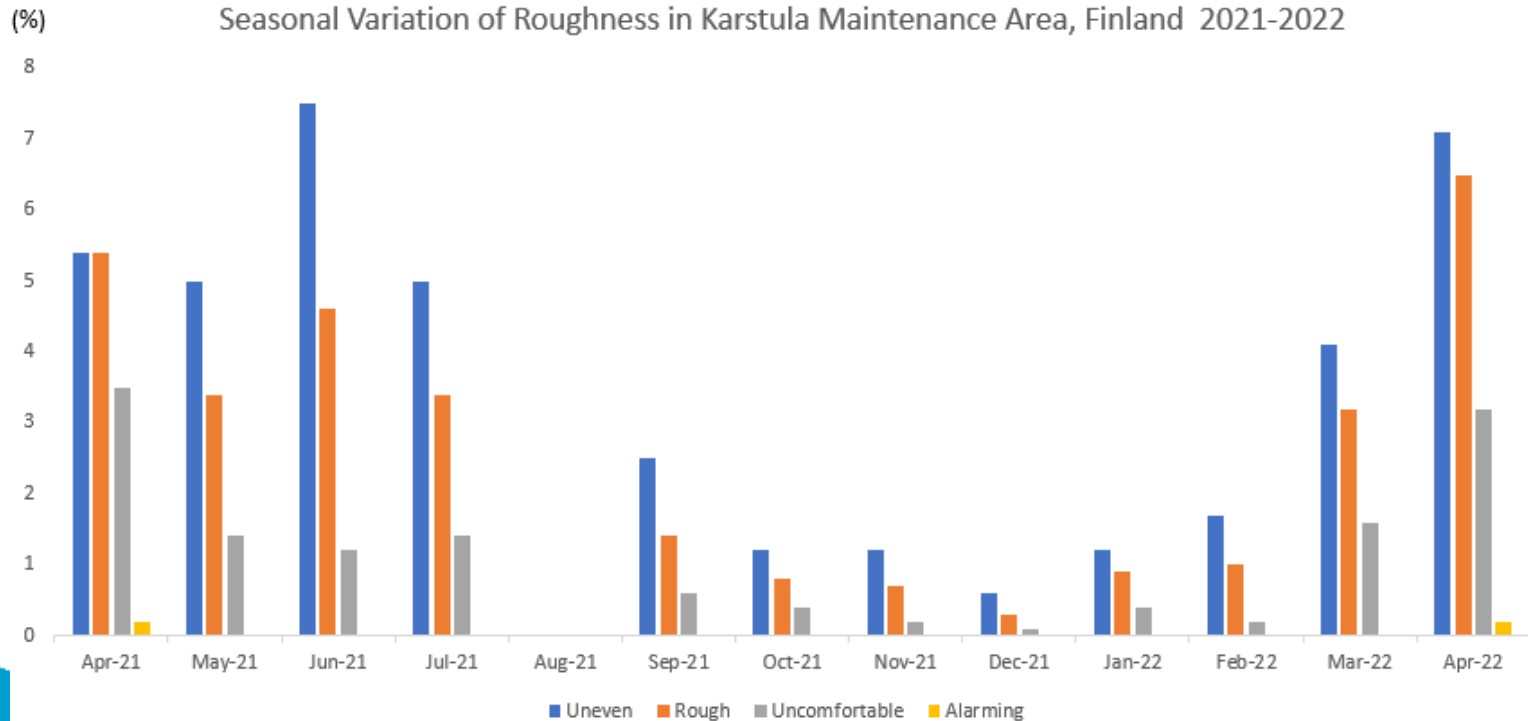
RDMC TECHNIQUE IN MONITORING SEASONAL VARIATIONS OF ROUGHNESS - KARSTULA MAINTENANCE AREA PAVED AND GRAVEL ROADS, FINLAND

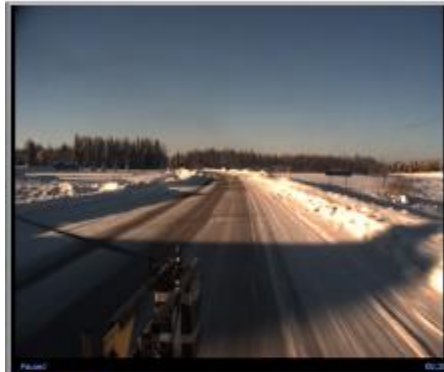
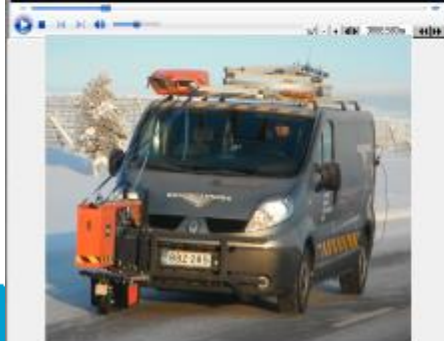
GPR Based Frost Diagnostic - Pajala Svappavaara Mine Road, Sweden

Detection of unfrozen water (ice lenses) in frozen ground

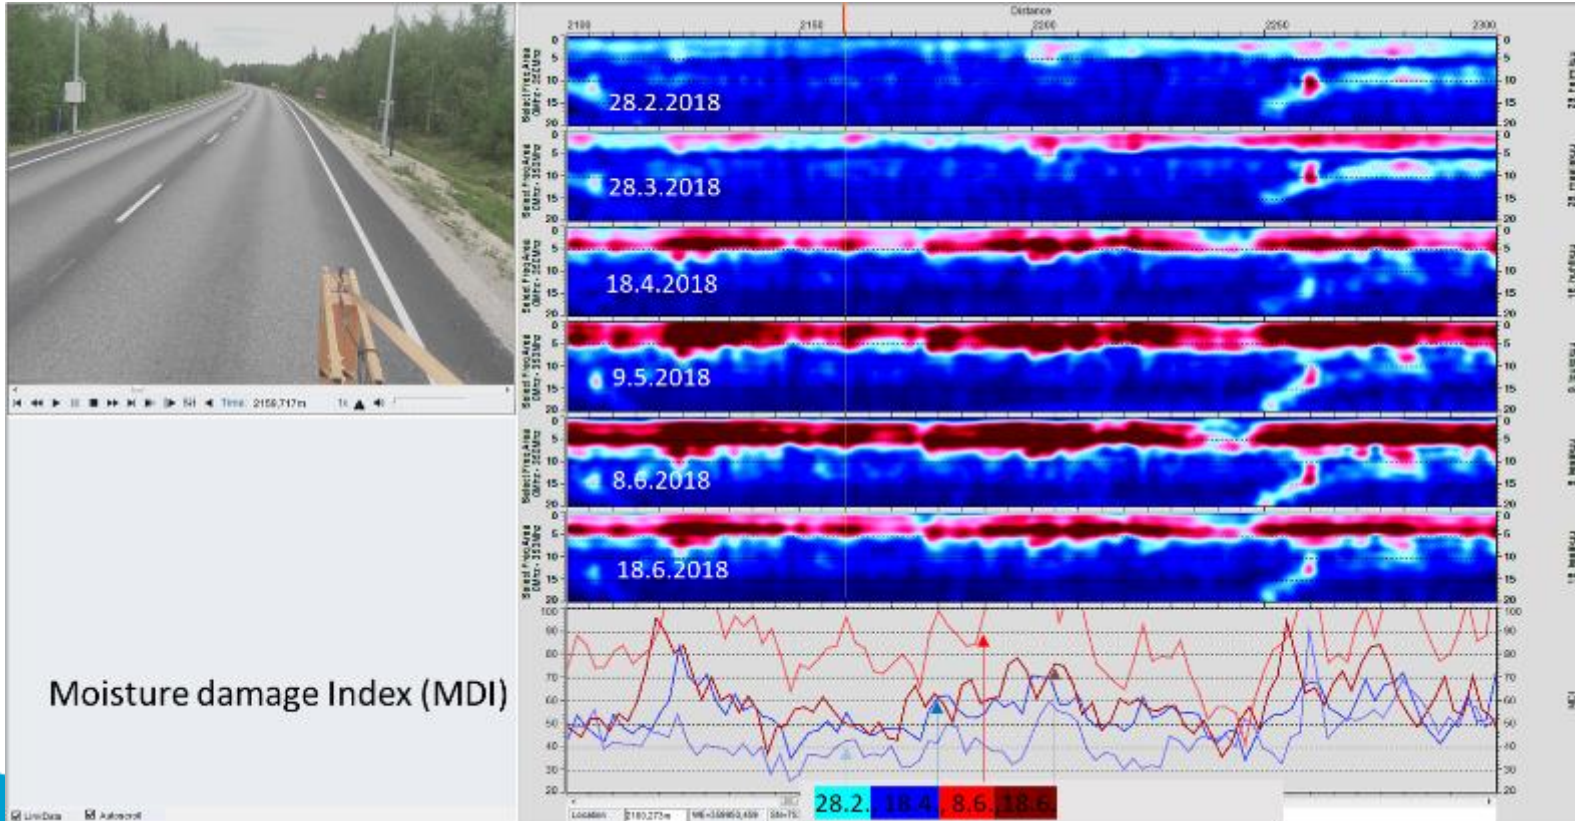
Moisture Damage Index Calculated from 400MHz GPR Data in Spring 2018 - Aurora test site, Finland
