Winter Maintenance and Frost Problems

Tomi Herronen, Roadscanners Oy

BCRR
Trondheim
27.6.2022

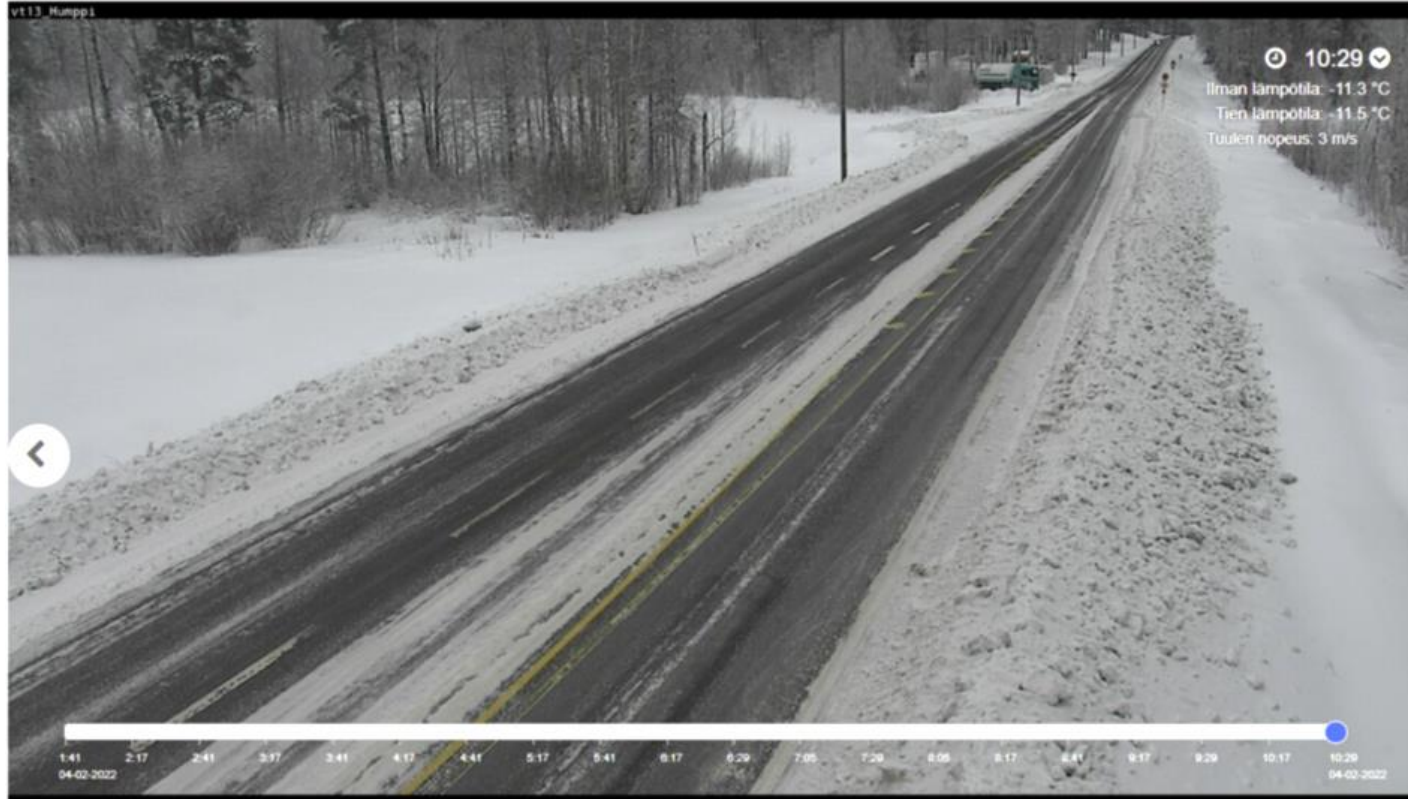
Frost in late winter

- Road structure frozen down to 2,5 m depth
- Snowbanks contain a high amount of water late in the winter

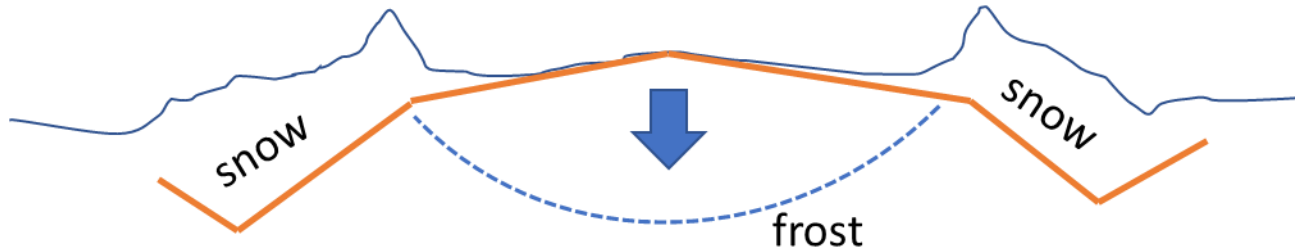
Spring and snow / melting

- Water/snow/ice on road (safety hazard)
- Due to cryosuction water flows into the road structure

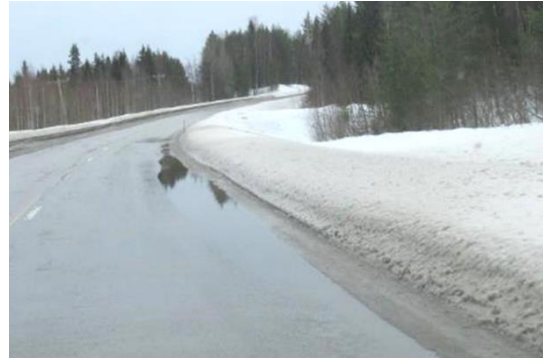
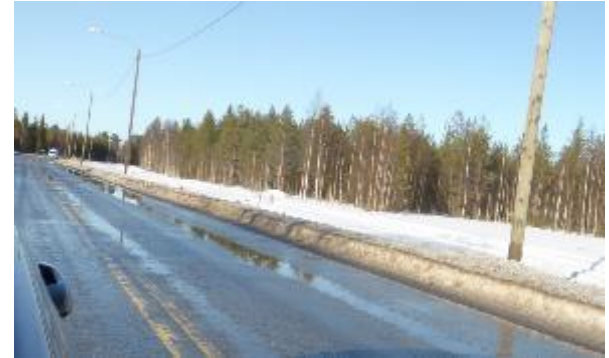
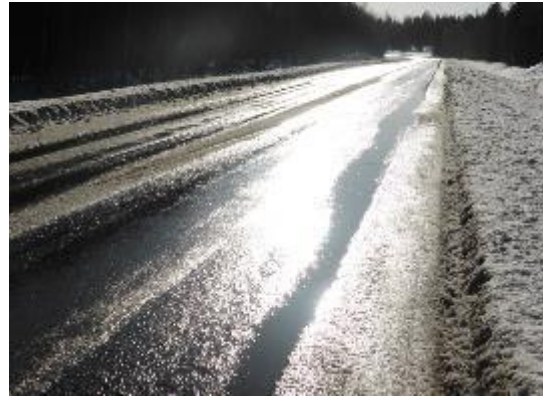
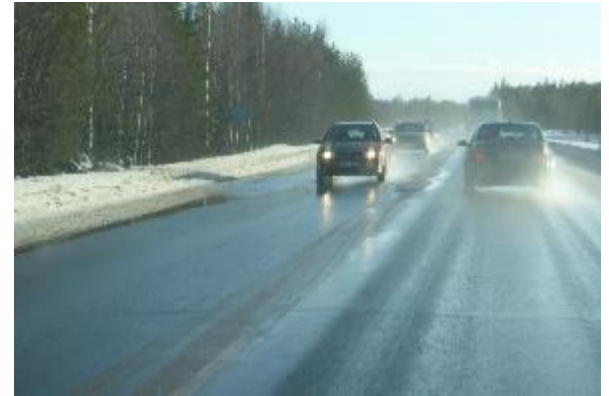
Snowbanks and Pavement Deformation

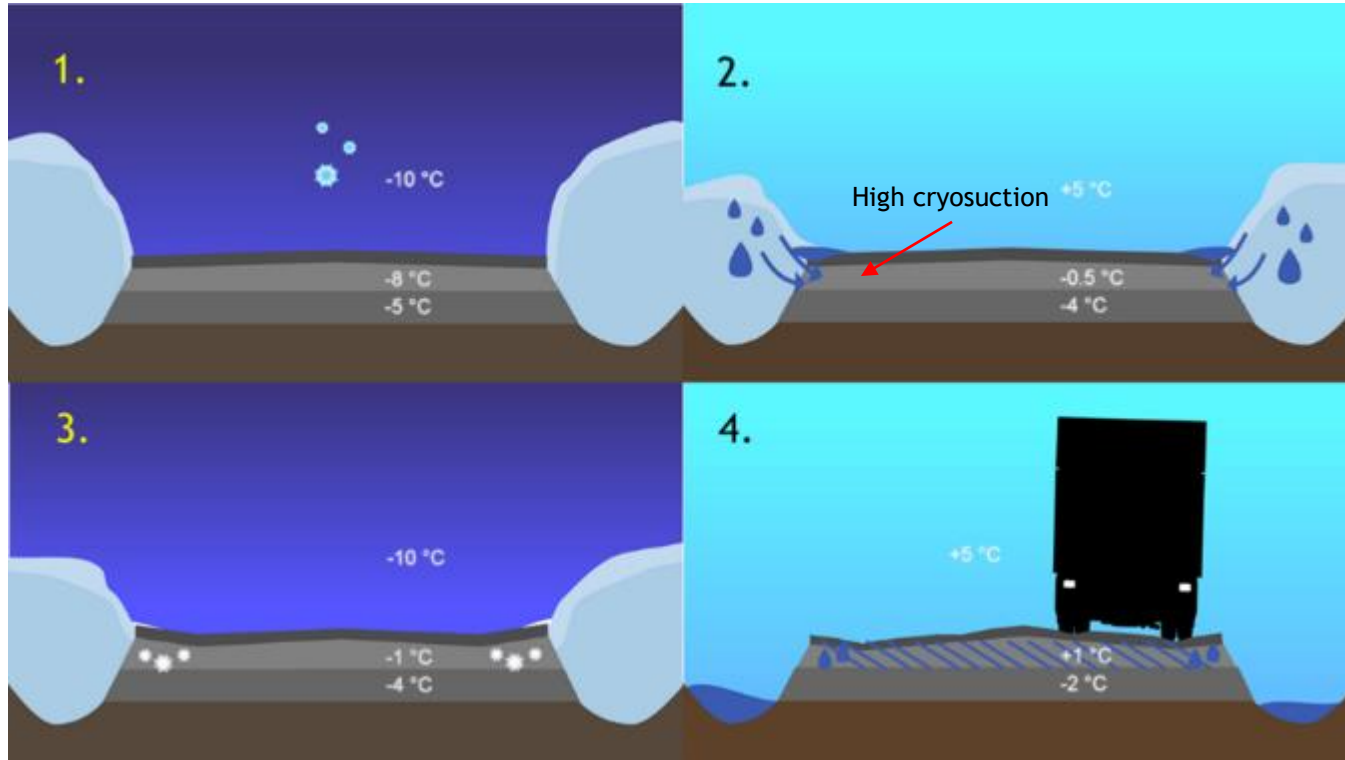
The Process – Tertiary Ice Lenses

TOTAL HEAVE

- Primary (In-Situ, 9% expansion)
- Secondary (Segregational heave)
- Tertiary (Ice-lens growth in frozen zone)

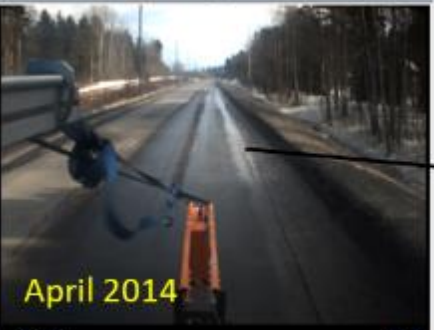
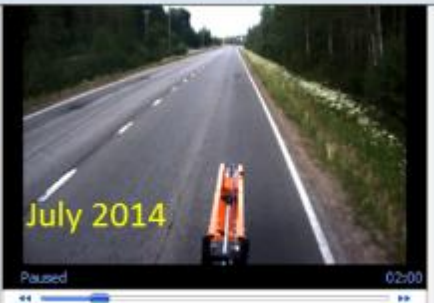
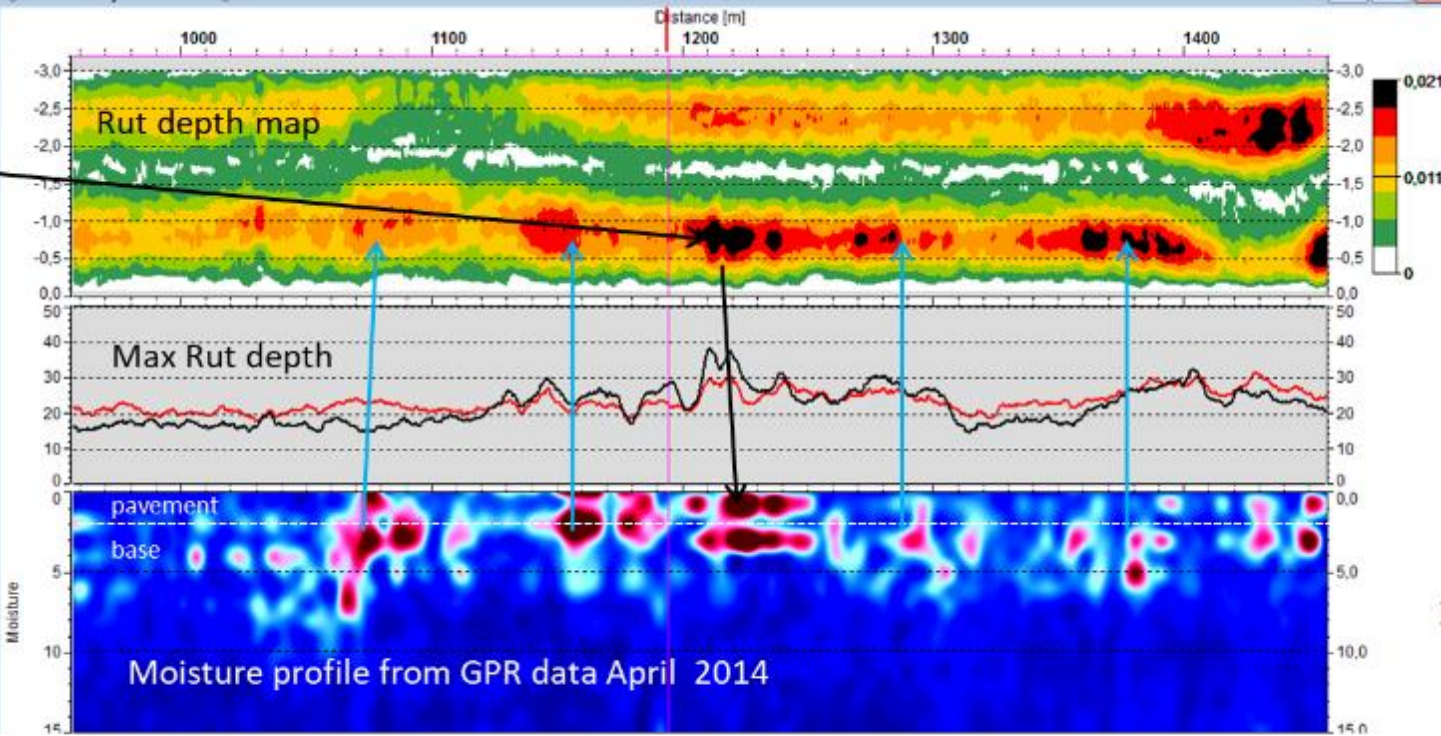
Water in Pavement and Base Course – Results from tests in Finland

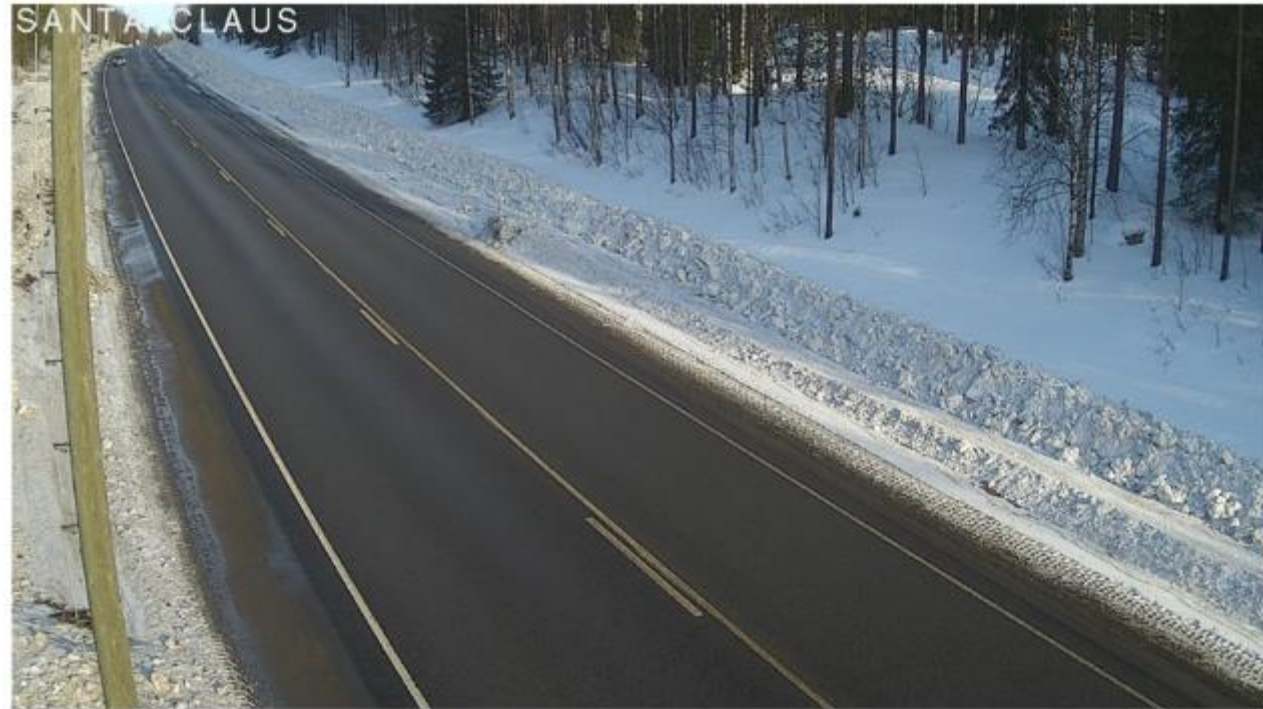
Snowbank removal before melting

- Pushing the snow into ditches
- Reducing the amount of water accessible to road structure
- Improving road safety

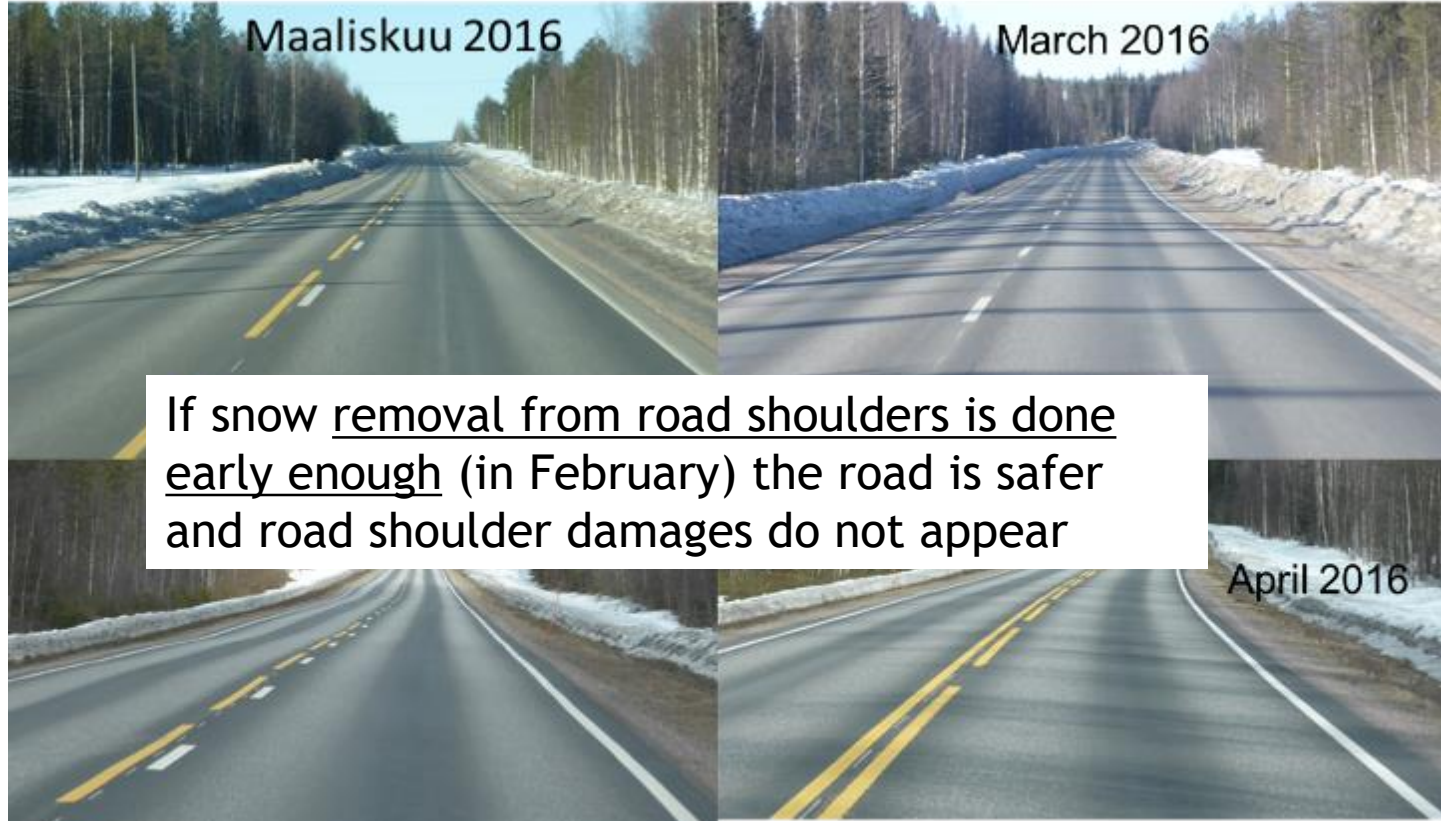
Tie 4 Rovaniemi, Santa Claus

PEHKO Findings 2016

If snow removal from road shoulders is done early enough (in February) the road is safer and road shoulder damages do not appear

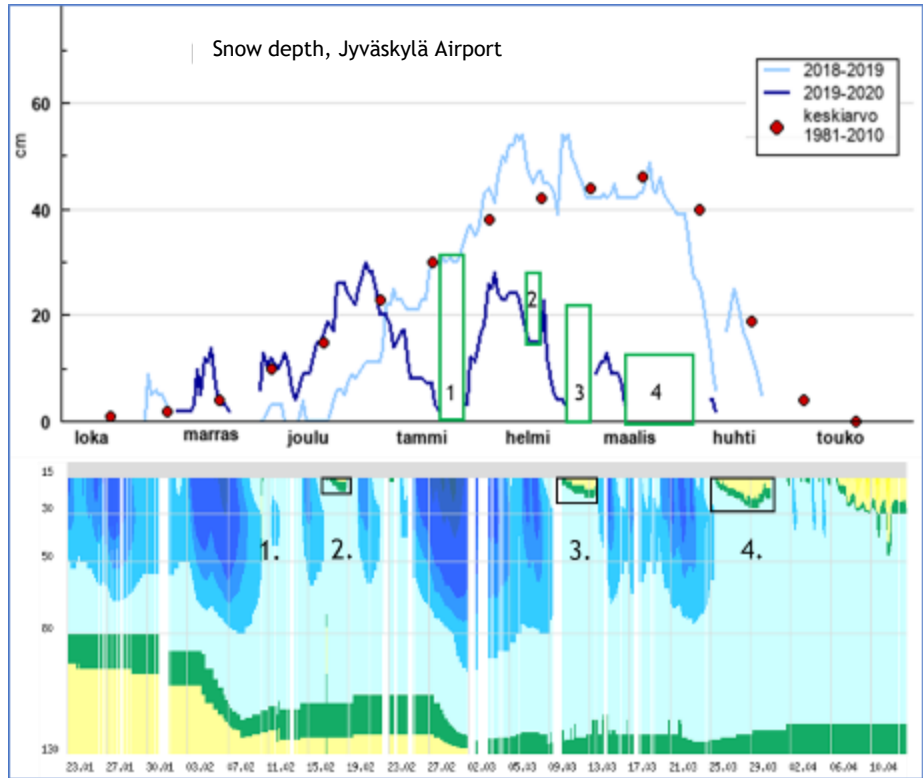
Repeated snow removal possibly required

- Several snowing/melting periods
- Snow removal should have been done several times
- Road structures stayed wet

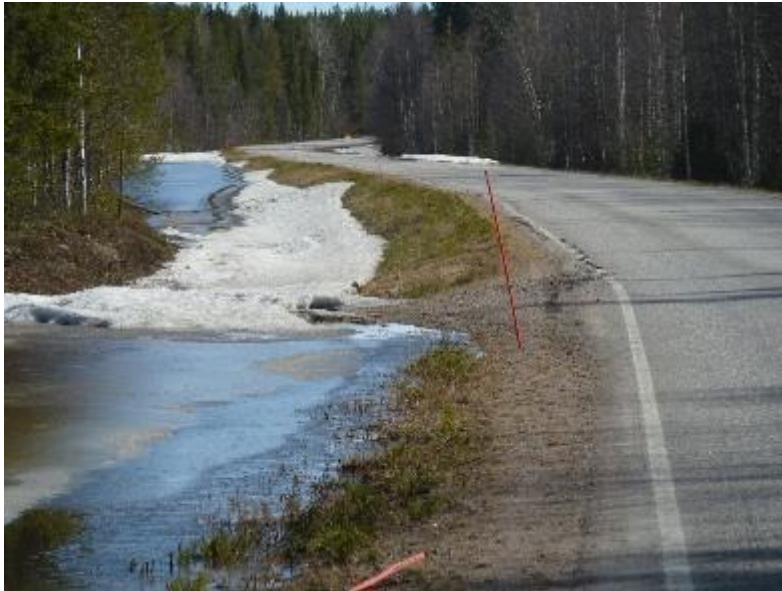
Frozen or clogged private access road culverts leading to deformations.
Annual cost effect: ~10%

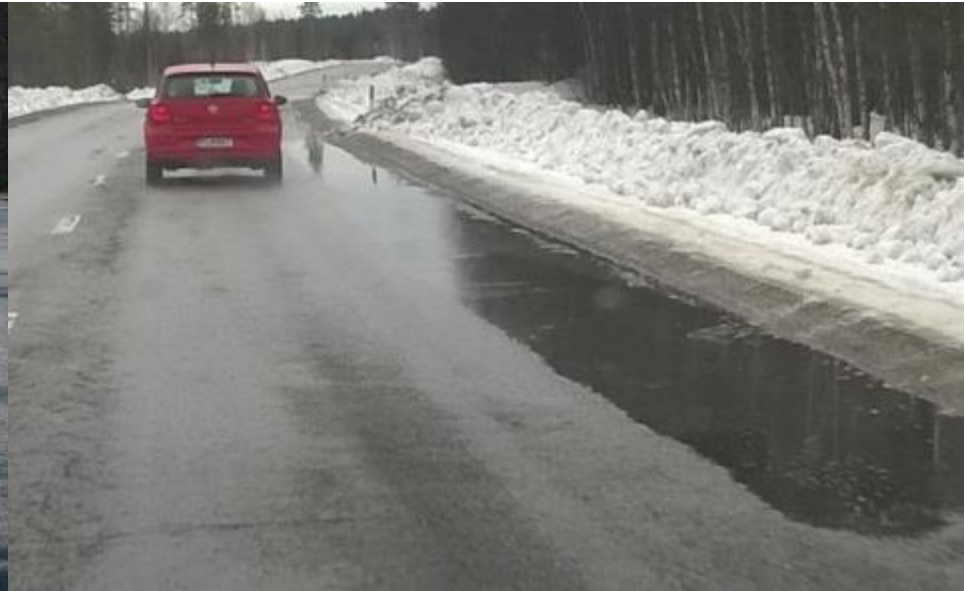
Delayed snow removal from road shoulders leading to water infiltration under the pavement and permanent deformations.
Annual cost effect: 13 - 17 %

With better winter maintenance it is possible to cut even 50% of the annual paving backlog in Finland (50-60 M€)

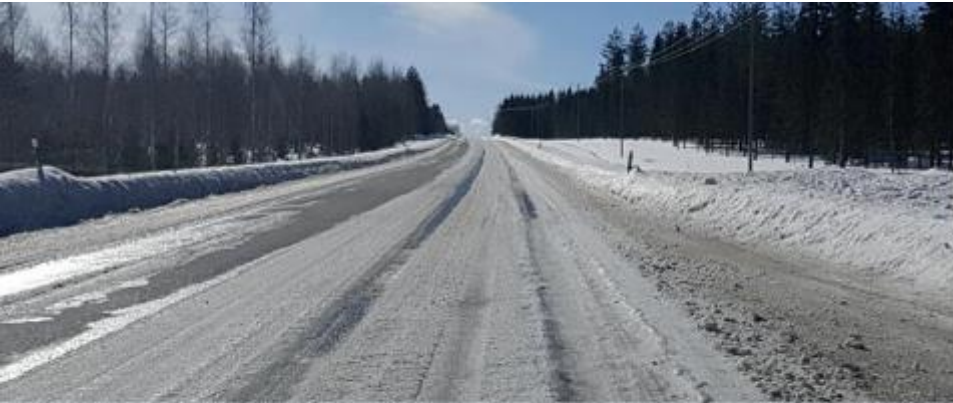
March 31st, 2018. Road outside PEHKO areas

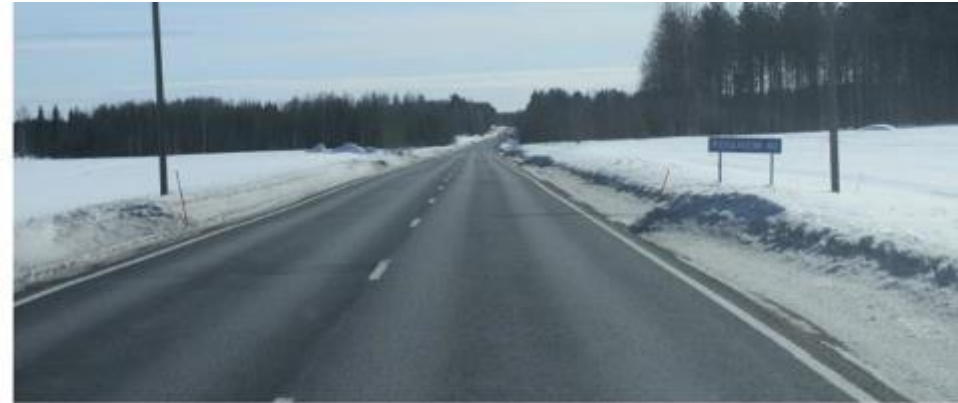
March 31st, 2018. PEHKO Road
