HydroCen – WP 1.1 Tunnel Systems

Professor Bjørn Nilsen,
Department of Geoscience and Petroleum (IGP),
Norwegian University of Science and Technology - NTNU

Main basis of Norwegian tunnelling technology: Hydropower development

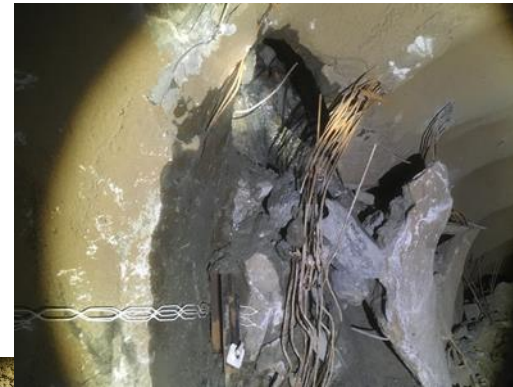
Matre Haugsdal 2017, ~20-30m³

- After 1 year of operation
- New adit and bypass required
- Cost of repair ~40 MNOK

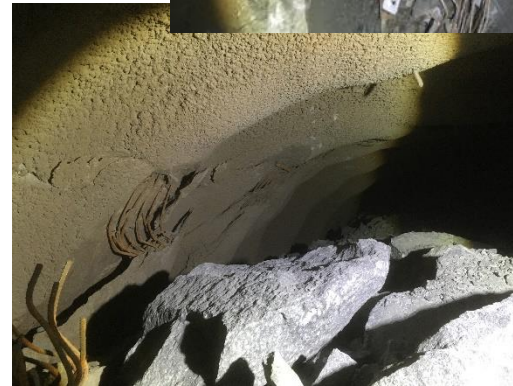
Nedre Vinstra 2015, ~2.500m³

- In TBM tunnel, after 26 years of operation
- Bypass required
- Estimated annual energy loss: 15 GWh

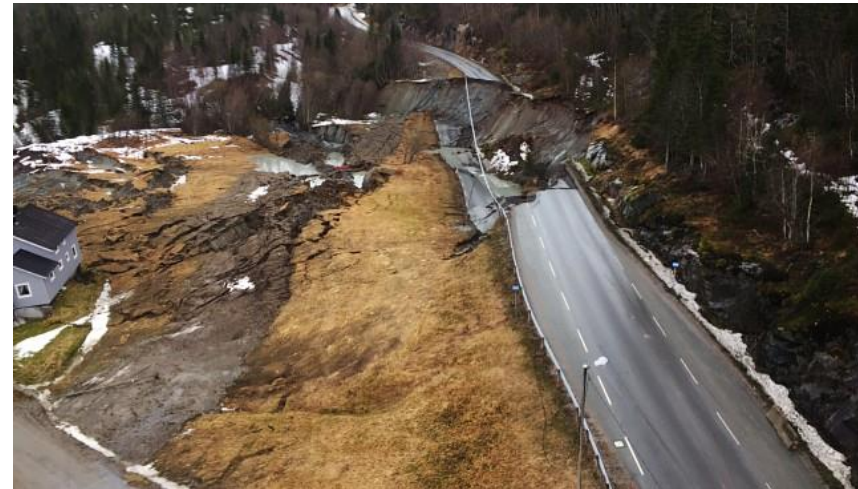
Recent case of hydraulic jacking caused by insufficient rock stress: Tosbotn

Tosbotn 1.-2.4.2016 => clay slide along highway
Total repair cost: >100 MNOK
