Behavior of Rubber Materials under Exposure to High Electric Fields

Abstract

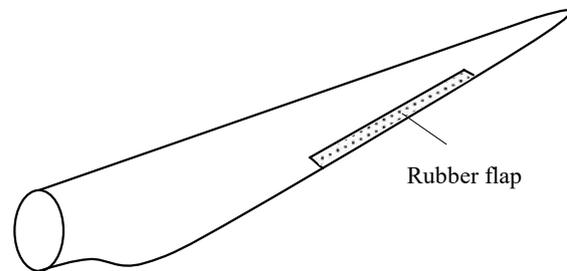
Fig.1 – Wind turbine blade equipped with a rubber flap system, installed on the blade trailing edge.

In the recent years, new technologies have been developed to increase the efficiency of wind turbine blades, some of which involve the use of rubber materials in the blade structure. Amongst these technologies, the deformable flaps aim at reducing the load on the blade, thus alleviating the fatigue strain on the whole wind turbine [1]. This is achieved by installing a rubber flap in the trailing edge of the blade (Fig. 1), and controlling its deflection using a compressed-air system. Once installed in the blade, the rubber flap will be subjected to severe ambient conditions. This paper is focused on the effect of high electric fields on the electrical performance of rubber materials.

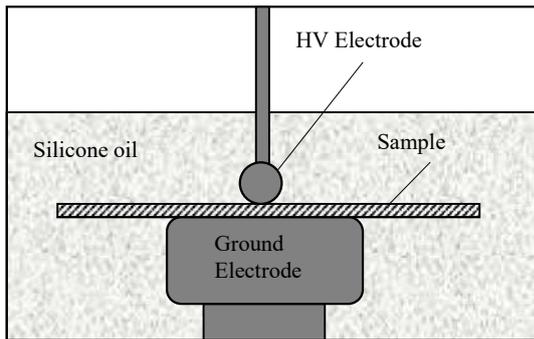
The sample is placed between two electrodes inside a container filled with silicone oil (Fig. 2). The upper electrode is spherical, with a diameter of 12.5 mm, and it is connected to the high impulse voltage generator. The lower electrode is cylindrical with rounded edges, with a diameter of 70 mm, and is connected to ground. The purpose of the silicone oil is to increase the electrical breakdown of the media around the specimen, in order to prevent side flashovers.

Fig.2 – Breakdown test setup: rubber sample placed between the high voltage and ground electrodes, inside a container filled with silicone oil.

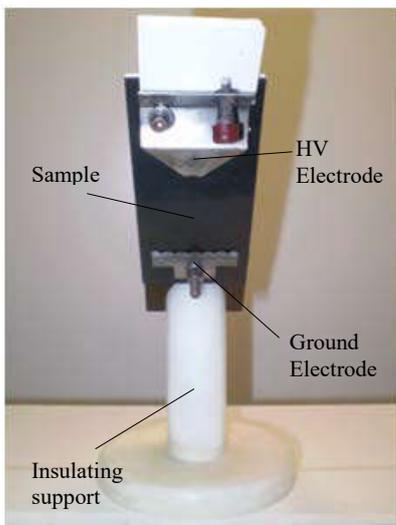
Fig.3 – Tracking resistance test setup. Sample of rubber material mounted on the insulating support with the electrodes.

The setup arrangement and the test procedure follow the standard setup described in [7]. The specimens are mounted on an insulating support, which stands at an angle of 45 degrees from the horizontal. Two electrodes are placed on the top and the bottom of the sample, connected to high voltage and ground respectively (Fig. 3). The specimens are arranged in sets of 5 samples. Each sample is 50 x 120 mm, with a thickness of 2 mm (Fig. 4).

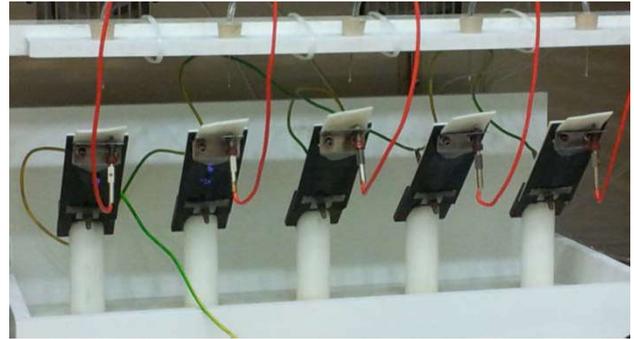
Fig.4 – Tracking resistance test setup. Set of 5 samples mounted on the supports.

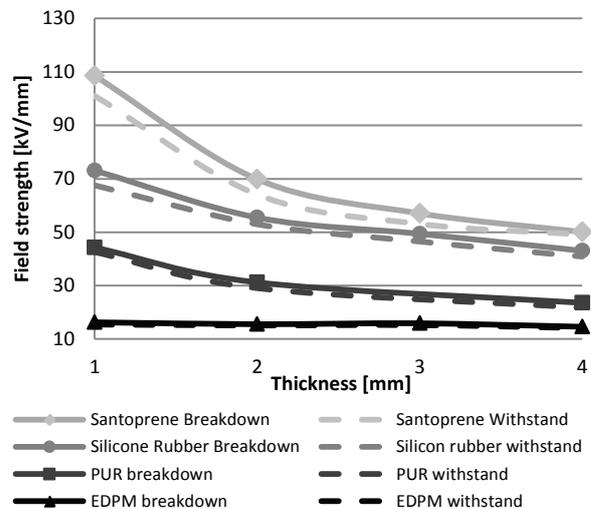
The breakdown strength tests were performed on 6 samples of each thickness, for the four different rubber materials. The average breakdown and withstand voltages for each material and thickness are displayed in Fig 5.

Fig.5 – Breakdown and withstand field strength of the tested materials, for thicknesses from 1 to 4 mm.

According to the test results, the Santoprene material presents the highest breakdown field strength of 110 kV/mm, followed by silicone rubber showing 72 kV/mm. It is also observed that the breakdown strength decreases when increasing the thickness of the sample. This can be explained by the so-called volume effect, where an increase of the material thickness involves a higher probability of impurities or microscopic defects. These inhomogeneities, normally small particles and air bubbles, enhance the electric field around or inside them, and lead to an earlier breakdown of the material. The volume effect can be found in all the tested materials except the EPDM. Considering that this material shows a very low breakdown strength, the negative influence of possible impurities is less dominant.

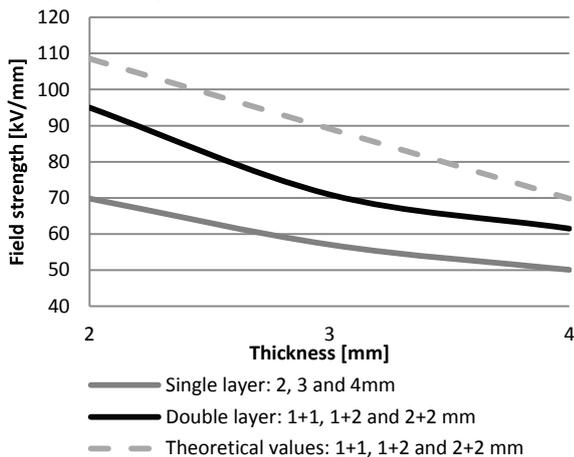
Fig.6 – Comparison of breakdown field strength between single-layer setup, double-layer setup and theoretical values for the double layer setup calculated from the breakdown strength of the independent layers.

In order to study further the volume effect and the influence of interfaces, additional tests were performed to Santoprene, the material showing the highest breakdown strength. These tests consisted of testing two layers of material together. The results were compared to the breakdown strength of a single layer with the same total thickness and with the theoretical calculation of the breakdown strength obtained from the independent layers.

The test reveals that the double-layer setup has higher breakdown strength than the single-layer setup. At a first glance, this may be surprising, since we have an additional interface in the material. On the other hand each layer of the double-layer setup presents fewer impurities per volume than the thicker single-layer, which makes the result more plausible. It is also found that the breakdown strength of the double-layer setup is lower than the value calculated from each independent layer. This fact indicates that in the double-layer setup, the breakdown occurs first in the weakest layer, directly followed by the other layer. Therefore, the weakest layer determines the breakdown of both layers. This phenomenon is more evident in the case of mixed thickness (1+2 mm), where the difference between the

calculated and the actual breakdown strength of the double-layer is greater.

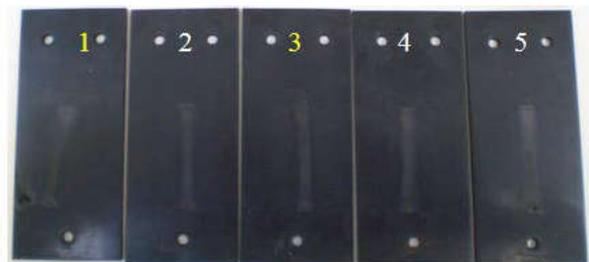
Fig.7 – Surface erosion in Santoprene rubber material after the tracking resistance tests. Samples 1 and 3 failed.

The end-point criterion chosen for the tracking tests depends only on the level of current flowing through the sample. Still, it is relevant for this investigation to look at the erosion of the samples after the tests, since it varies considerably in materials that withstand a similar level of voltage. Figs. 7 to 10 show the surface erosion of the samples after the tests.

It is seen in the pictures (Figs. 7-10) that all the samples show a matt appearance between the electrodes. However, this band is different in each material, and only some materials present a deep track. The Santoprene and EPDM materials have a narrow track. The Santoprene samples present erosion only next to the bottom electrode, while the EPDM samples have severe erosion in the whole path between the electrodes. The silicone and PUR materials have a wider dry band and no significant erosion. A failed sample of each material is shown in Fig. 11.

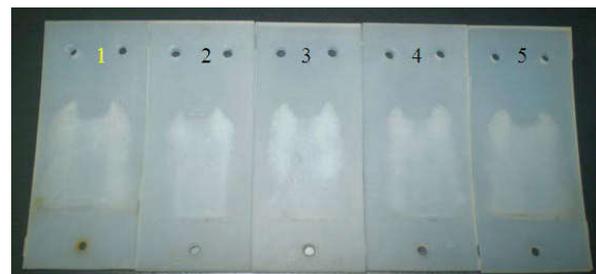
Fig.8 – Surface erosion in Silicone rubber material after the tracking resistance tests. Sample 1 failed.

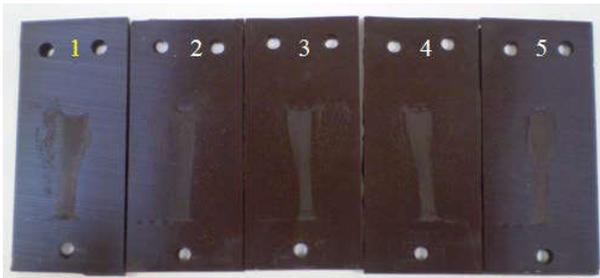
Fig.9 – Surface erosion in PUR rubber material after the tracking resistance tests. Sample 1 failed.

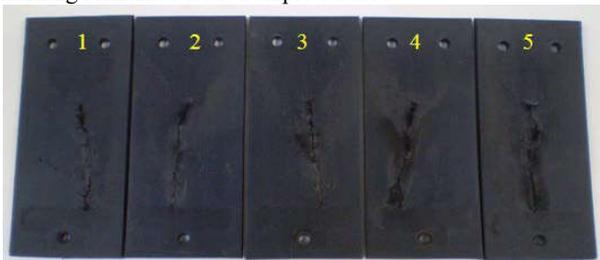
Fig.10 – Surface erosion in EPDM rubber material after the tracking resistance tests. All samples failed.

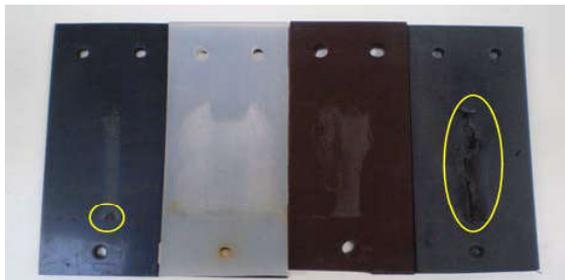
Fig.11 –The surface erosion (marked in yellow) and dry band can be compared in failed samples of each material. From left to right: Santoprene, Silicone rubber, PUR, EPDM.
