# Breakdown Behaviour of Damaged Low-Voltage Cables: Laboratory Experiments and Field Experience

## Abstract

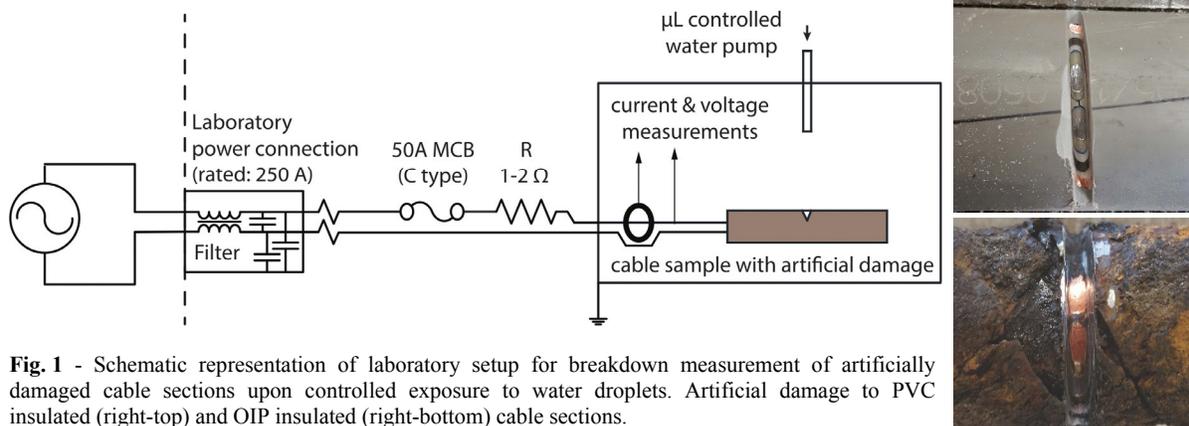
**Fig. 1** - Schematic representation of laboratory setup for breakdown measurement of artificially damaged cable sections upon controlled exposure to water droplets. Artificial damage to PVC insulated (right-top) and OIP insulated (right-bottom) cable sections.

Experiments have been conducted on samples of PVC insulated cable with 95 mm<sup>2</sup> aluminium conductors and on OIP insulated cable samples with 35 mm<sup>2</sup> copper conductors. Artificial damage was inflicted by using an angle grinder. Damage in the form of a slit was made of such depth to reach the minimum distance between two conductors. For the PVC and OIP insulated cables this distance was 3.0 and 1.7 mm respectively (Figure 1). Nominal voltage (400 V<sub>RMS</sub>) is applied to the two affected conductors via resistors connected in series to limit the short-circuit current. To prevent unwanted outages the test setup current was limited such that a 50 A circuit breaker would not break (the connection was rated at 64 A). Current and voltage measurements were conducted as close to the damaged cable section as possible (about 10 cm distance). The current is measured using a current probe with a bandwidth from 5 Hz to 2 MHz. The voltage is measured using a differential probe with bandwidth from DC to 20 MHz. Development of the fault was enforced by means of repeatedly exposing the damaged spot to water droplets. The rate was set to 90 s interval between successive drops (this appeared a practical value to achieve result within a reasonable test duration). The water conductivity was set to 2 mS/cm. This is higher than for average ground water conductivity (0.7 mS/cm, [6]), but was chosen for obtaining faster results. Its value was low enough not to cause a direct breakdown. A comparison was made with lower water conductivity as verification, showing no significant difference except for the shorter time till breakdown.

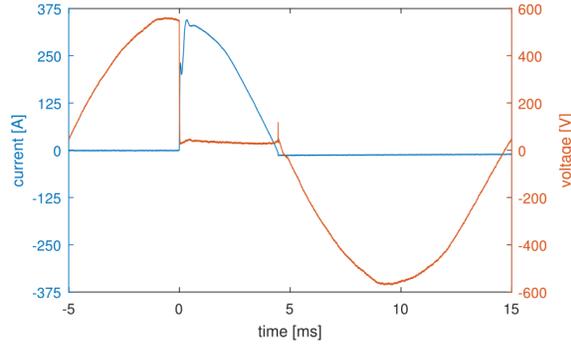
A typical transient as measured with the PVC insulated cable is given in Figure 2. The current follows the amplitude profile of the line voltage and the arc voltage remains relatively constant, suggesting that the arc conductance is proportional to the arc current. Shortly before the arc voltage zero crossing, the arc current reaches zero. An offset is observed in the current magnitude just after crossing zero, due to the current probe having a pass-band characteristic starting at 5 Hz. As the arc extinguishes when a voltage is still present, a transient recovery voltage is observed when the current reaches zero.

**Fig. 2** - Typical voltage and current waveform during a breakdown.

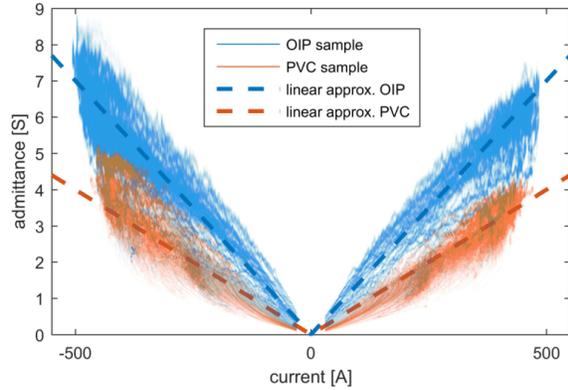
Voltage and current patterns have been recorded for up to 100 breakdowns to study the development of a fault. For the PVC cable sample, this took approximately 3 hours, while with the OIP cable sample it took about 4 hours. Figure 3 shows the arc admittance for 100 accumulated breakdowns for both the OIP and PVC samples. A large variability is observed: over ±20% with respect to the average value. Whereas the arc often extinguishes close to the voltage zero crossing in case of the OIP cable sample, in many cases the arc extinguishes earlier for the PVC cable sample. The minimum arc voltage is lower for the OIP cable sample. This is likely related to the shorter conductor distance, which may also be the cause of earlier extinction. With both sample types, the arc admittance scales nearly proportional to the arc current. Linear approximations are given in Figure 3 with slopes of 14 mS/A for OIP and 8 mS/A for PVC. There is a small difference between the positive and negative current cycles. Roughly similar characteristics are also observed in [7]. If the arc admittance is modelled as a linear relation with the current, the coefficient represents the reciprocal arc voltage, i.e. the near constant arc voltage observed in Figure 2. The admittance coefficients  $\beta$  of 14 mS/A and 8 mS/A correspond to arc voltages 71 V and 125 V for OIP and PVC respectively.

**Fig. 3** - Simultaneous plots of the arc admittance vs. current for OIP and PVC samples.

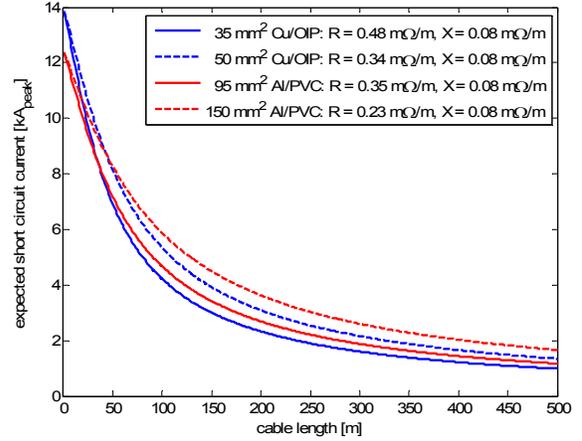
are taken from the experiments in Section 2.2. These arc admittances are associated with the shortest arc length possible for the respective cable type as the experimental samples were damaged accordingly. In practice the damage may be such that the arc length is longer, thus lower currents may be expected. The expected peak current versus the cable length is given in Figure 4.

**Fig. 4** - Expected peak current versus cable length with a 400 kVA transformer ( $R = 5.1$  m $\Omega$ ,  $X = 16.9$  m $\Omega$  for each LV phase) for different cable types given a phase-to-phase fault (per unit length resistance and reactance are provided). The Cu cables were OIP and the Al cables PVC insulated.

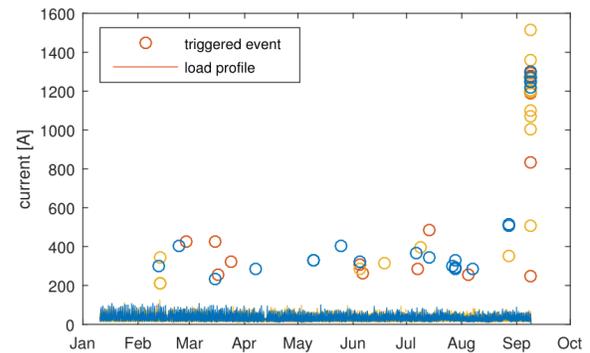
An OIP insulated cable with four 50 mm<sup>2</sup> copper conductors and in addition four 6 mm<sup>2</sup> copper conductors for the public lighting system. The cable has been monitored at the main conductors for 8 months until an outage occurred. An overview of the measurements is shown in Figure 6. During the measurement up to the outage 26 events have been recorded. An example of such event is shown in Figure 7. From the current profiles the 50 Hz base load current is subtracted in order to highlight the transient current. The amplitude is 270 A after compensation for the baseline load with a duration of 4 ms. The arc

initiated around the peak of the voltage. Over the course of measurement, several events have been recorded with comparable characteristics, mostly for phase 3 (blue), but also for the other two phases. A few days before the outage, a transient with duration of over a power cycle was recorded, Figure 8. Its duration was 30 ms and with amplitude of 270 A on phase 2 (yellow). The fault was found in a mass filled branch joint, at 225 m from the substation.

Fig. 6 - Overview of the measurements associated with case study 1. Daily averages are shown as line graph at the bottom, the circles indicate peak current from triggered events. Colours indicate different phases.

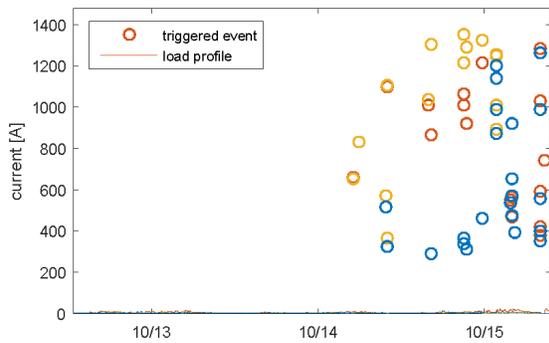
The measured cable has PVC insulation and 50 mm<sup>2</sup> aluminium conductors. The period of measurement was from 14 September till 17 October. An outage had occurred on 18 August, after which an automatic fuse was installed. No events have been triggered by the sensor until 14 October. Afterwards, 12 events have been triggered until an outage occurred at phase 2 later that day (spread over 19 hours). An overview of the last three days is shown in Figure 9. Further events are triggered (16 times, including 5 on which the installed automatic fuse interrupted) for about 9 hours, until the connection was taken out of service by the grid operator. Events are triggered upon transients at the other phases as well. The transient for the first event is shown in Figure 10. This pattern has typical breakdown characteristics with a short circuit between two phases. Most of the later events have similar patterns. All three phases are involved.

Upon investigation, a faulty component was found at 160 m distance from the substation. The actual failing component is not known. Because all three phases are involved, most likely a joint has failed. The automatic fuse recorded short circuit currents up to 2 kA.

**Fig. 9** - Overview of the last five days of measurements associated with case study 2. Daily averages are shown as line graph at the bottom, the circles indicate peak current from triggered events. Colours indicate different phases.
