# Behavior of partially saturated asphalt concrete pavement under freezing and accelerated pavement testing conditions

J.-P. Bilodeau, ing., PhD

O. Chupin, PhD

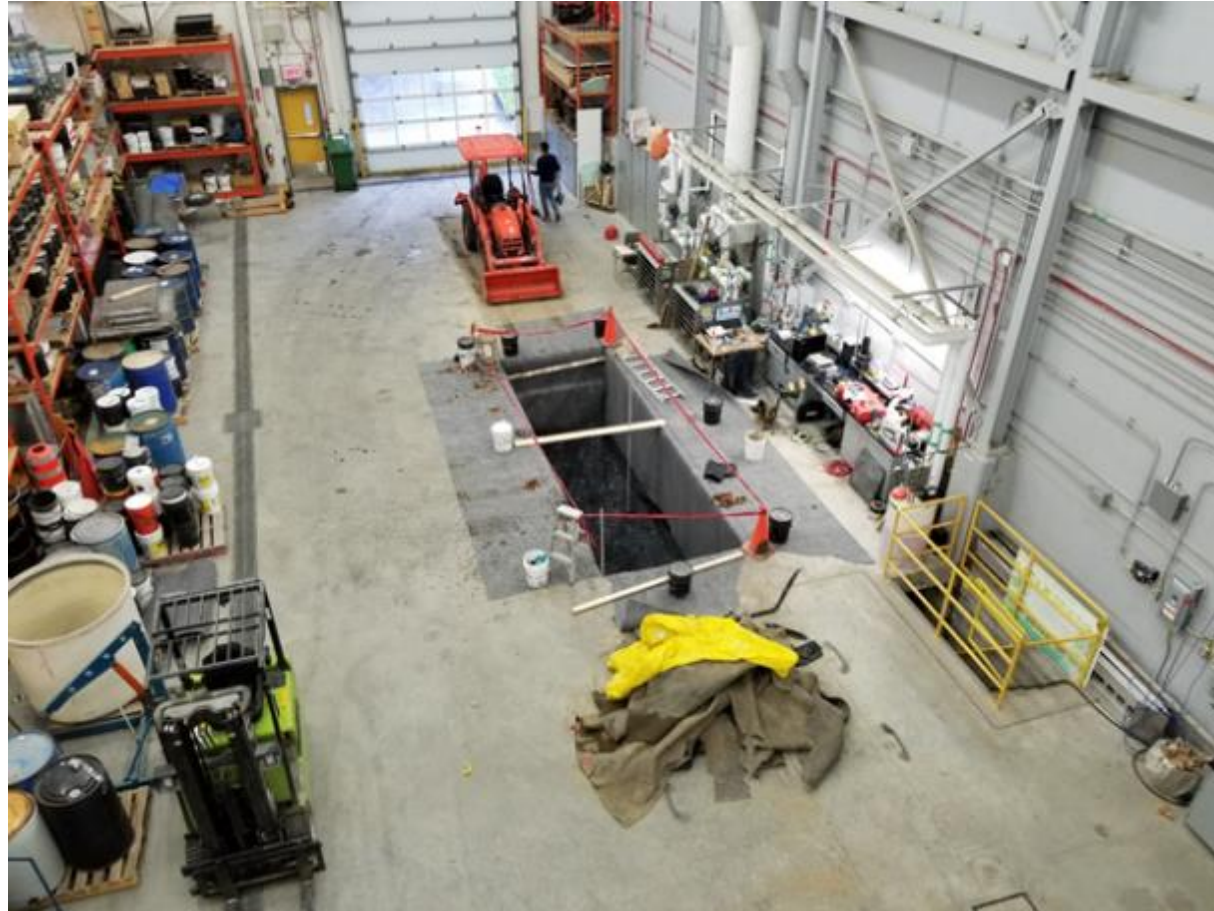
## Test pit

- 2 x 6 x 2 m
- Temperature control (bottom)
- Water table control

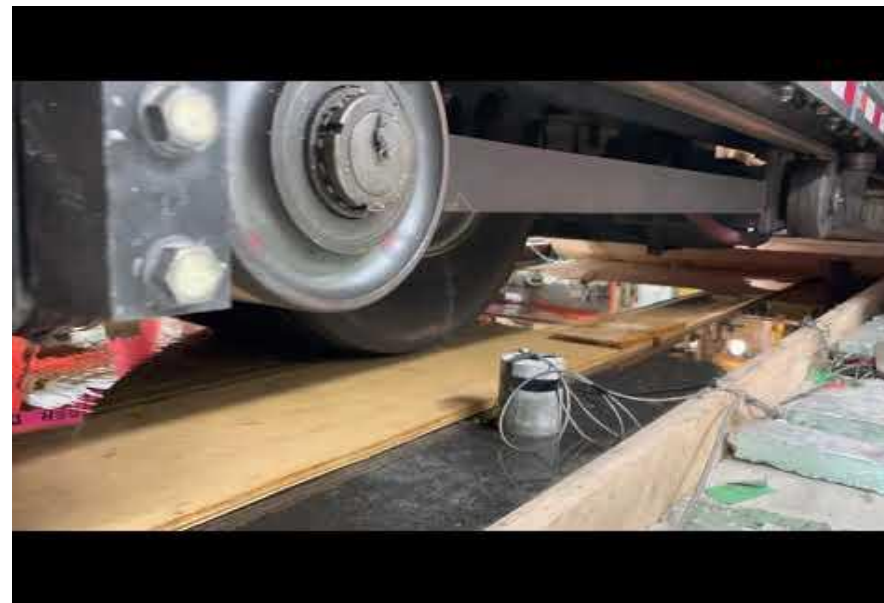
# AC layers debonding under freeze-thaw cycles

- Increasing the degree of saturation
- Estimated degree of saturation of the AC surface layer of 60 %

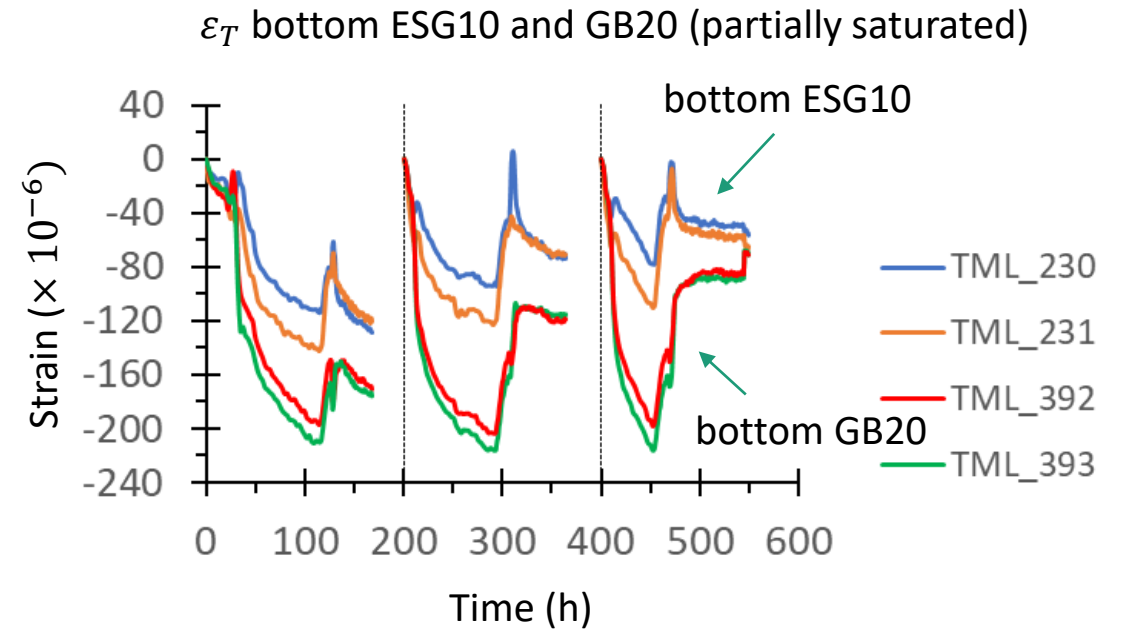
# Experimental facts: transversal strain at bottom of ESG10 and GB20

About the partially saturated structure (figure on right)

- Strains measured by different gages located at same depth in the AC layers quite similar
- Good repetition of the response along the 3 temperature cycles
- In contrast to the response under dry conditions (left): difference in the transversal strains measured at bottom of ESG10 and GB20  $\rightarrow$  diminishing the friction properties between the AC layers and introducing a swelling strain in the model

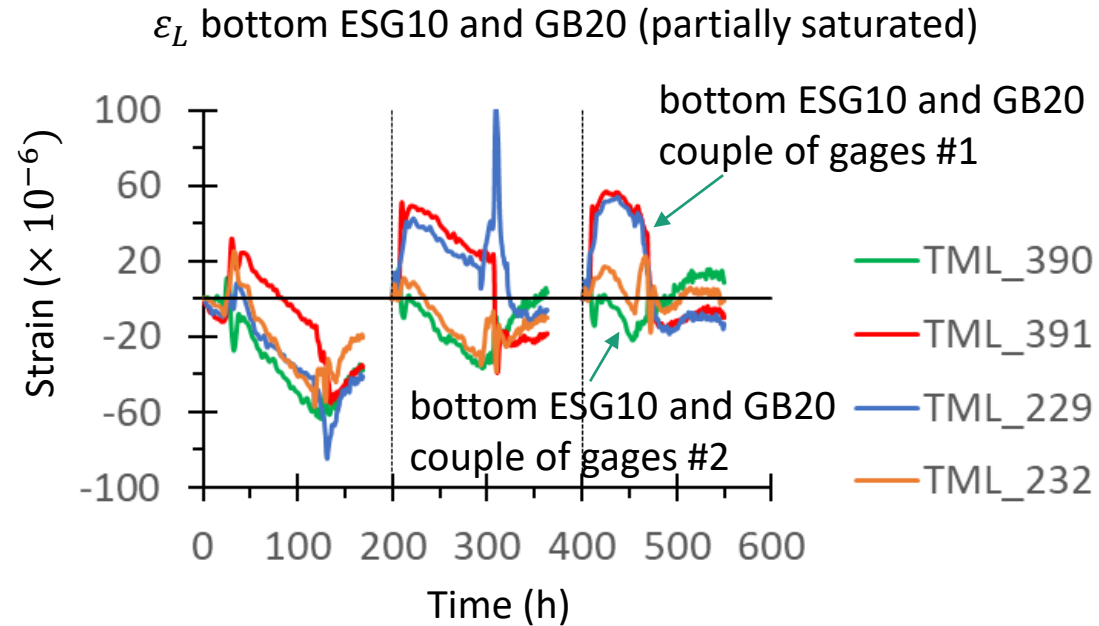
# Experimental facts: longitudinal strain at bottom of ESG10 and GB20

## About the partially saturated structure

- Longitudinal strains smaller than transversal ones but of significant values
- For a given couple of gages, longitudinal strain measured at bottom of ESG10 and GB20 similar  $\rightarrow$  keeping with “strong” friction conditions at bottom of GB20
- Strains measured by the 2 couples of gages evolves in the course of the temperature cycles
  - Values quite similar during cycle #1 but different at cycle #2 and #3
  - Could be explained by the development of vertical cracks in direction T close to couple of gages #1

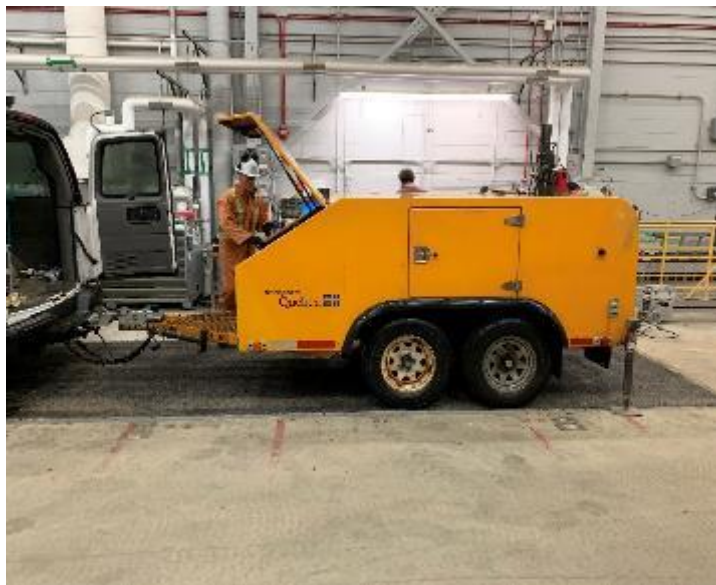
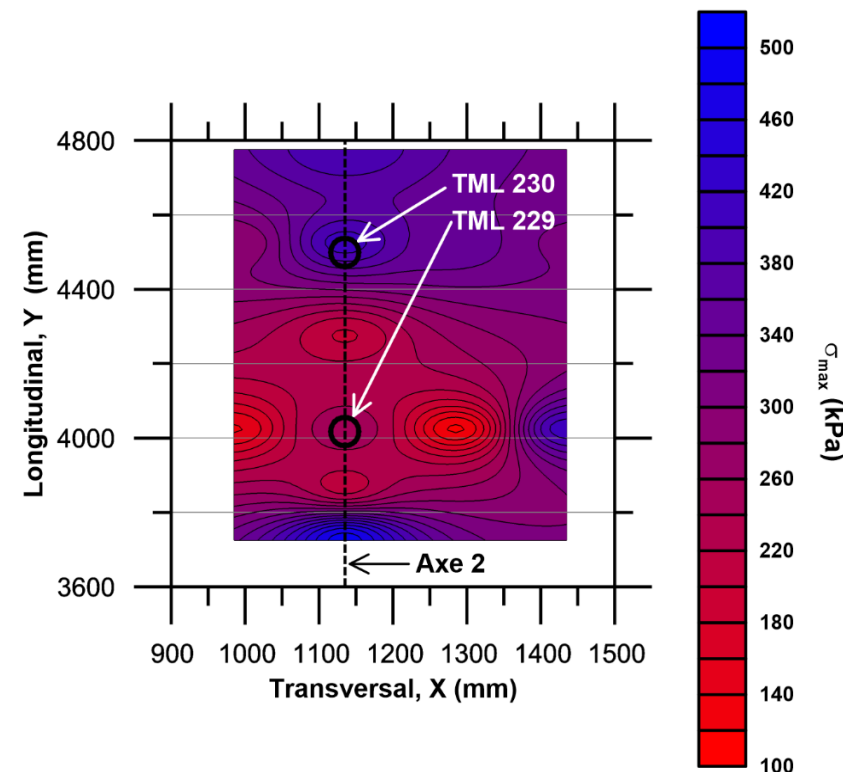
# Effect of F/T on the interface properties

- AMAC test

After construction

$\sigma_{\max} = 462$  kPa  
(perfect bond)

After wet + F/T

$\sigma_{\max} = 285$  kPa  
(moderate bond)

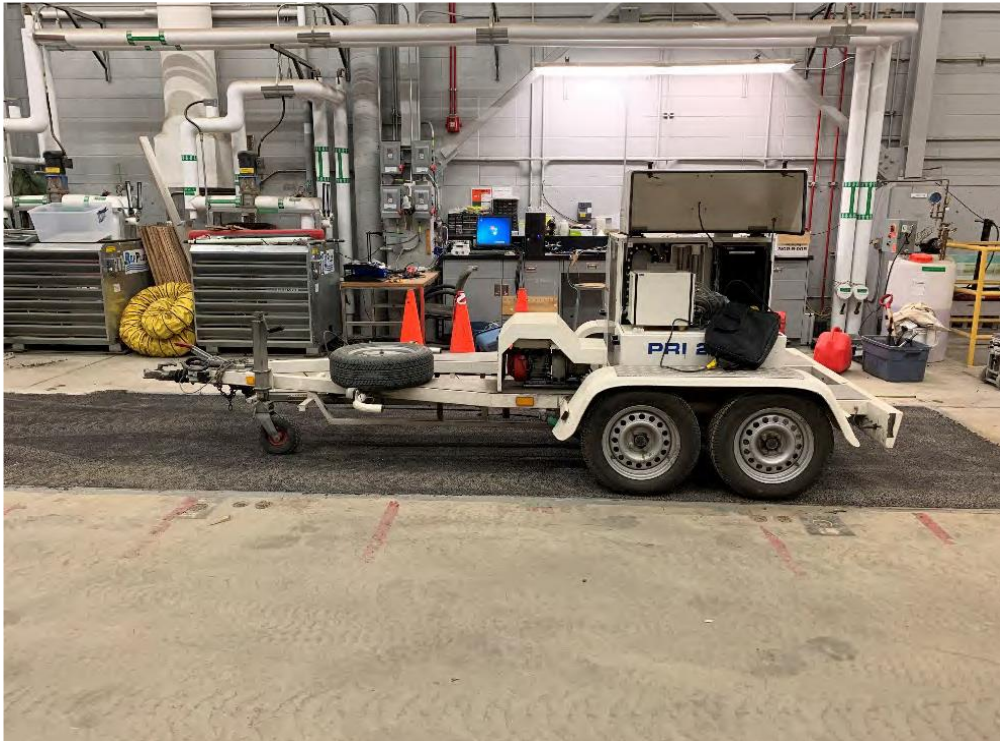
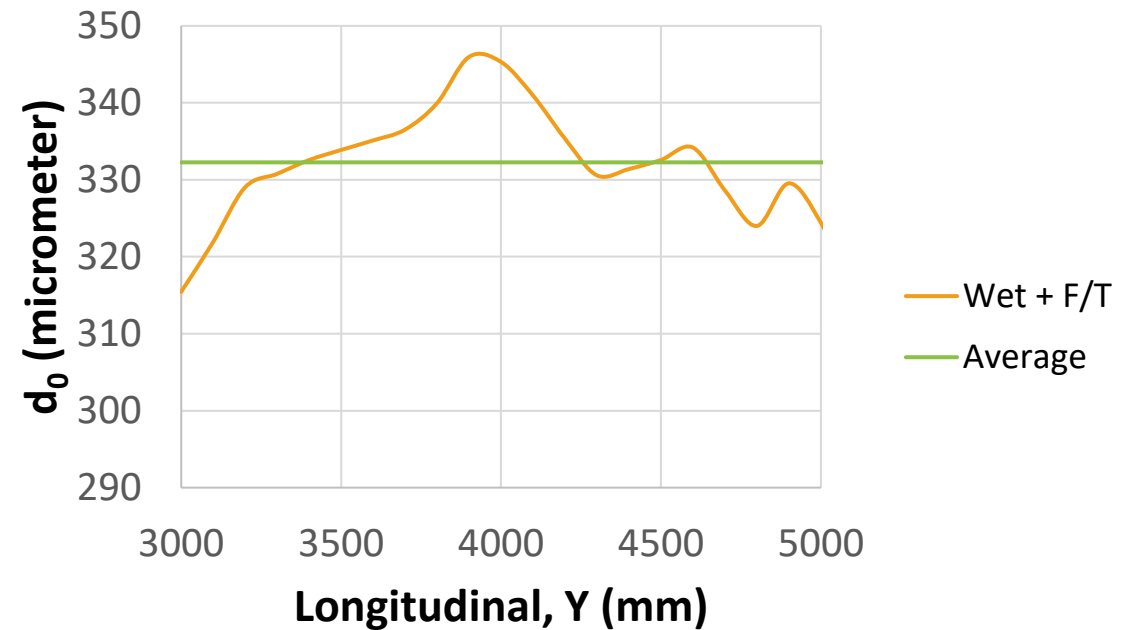
# Effect of F/T on the interface properties

- Deflection
