Three additional studies of coastal protection structures were started in 2013, where experience from site investigations, modelling and laboratory studies will be verified through large-scale field studies in 2014. The projects aims at studying different techniques for Arctic coastal erosion protection, with use of local soils that are adapted to local conditions:

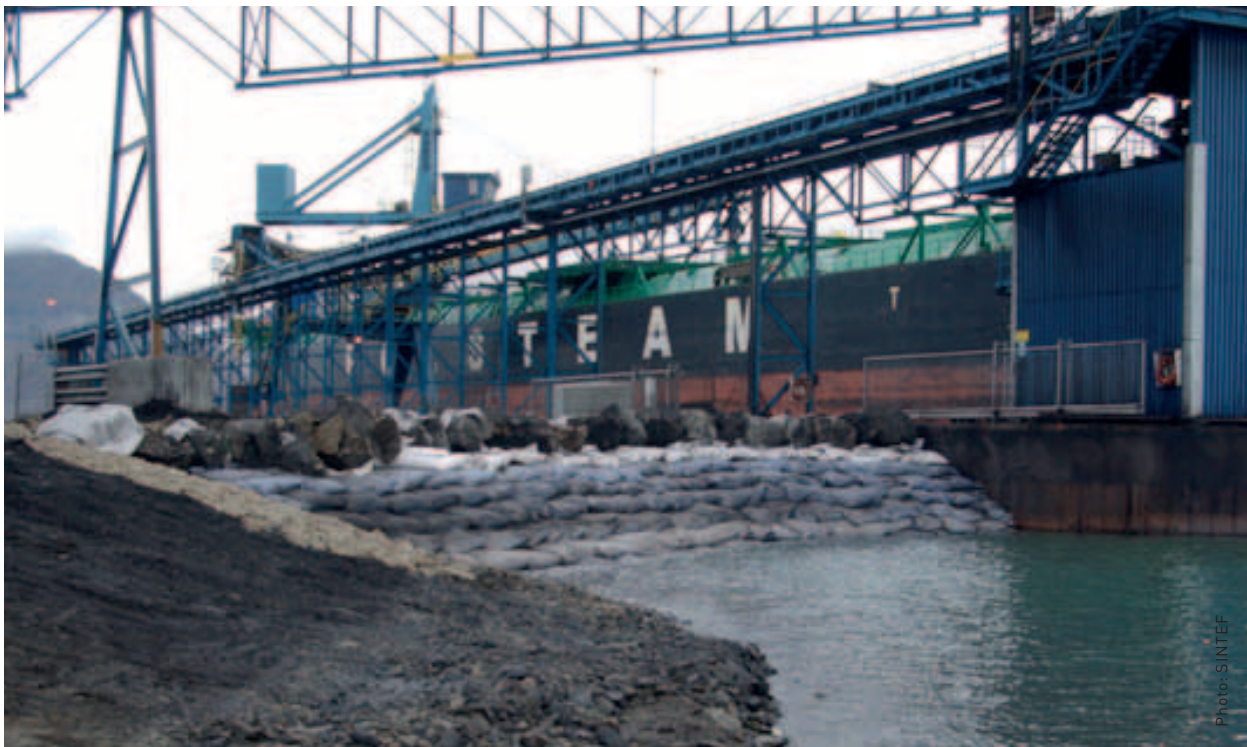
Erosion protection in Kapp Amsterdam, Svea.
